CITY OF ABERDEEN
CAPITAL FACILITIES PLAN

March 22, 2022

EXECUTIVE SUMMARY

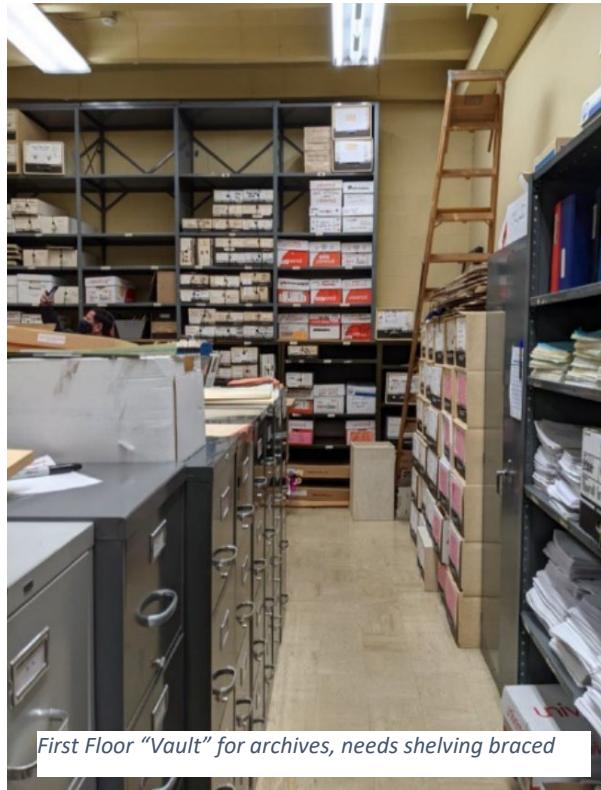
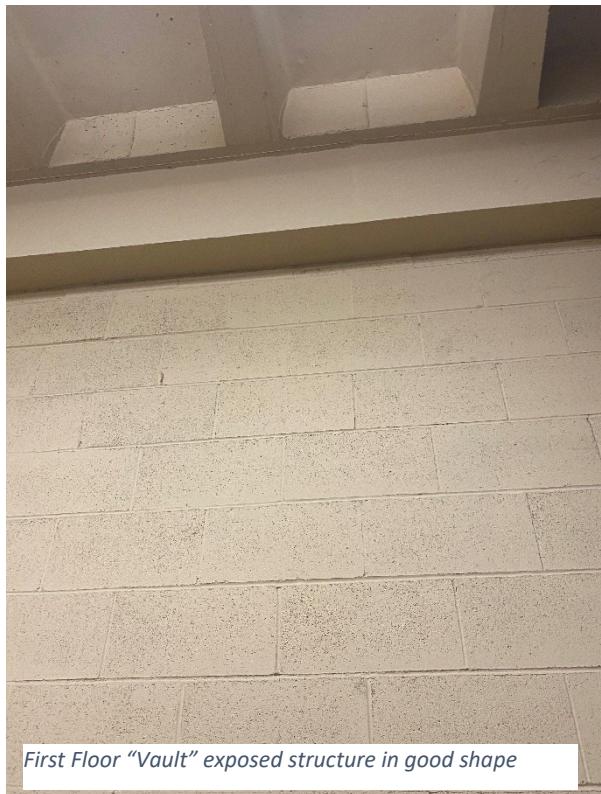
At the east end of the first floor is the “vault” that serves as a storage area for archives and city records. Shelving and high-storage areas need seismic bracing and files should be secured from toppling in a seismic event.

Data/Comm system is exposed and unprotected from potential damage.

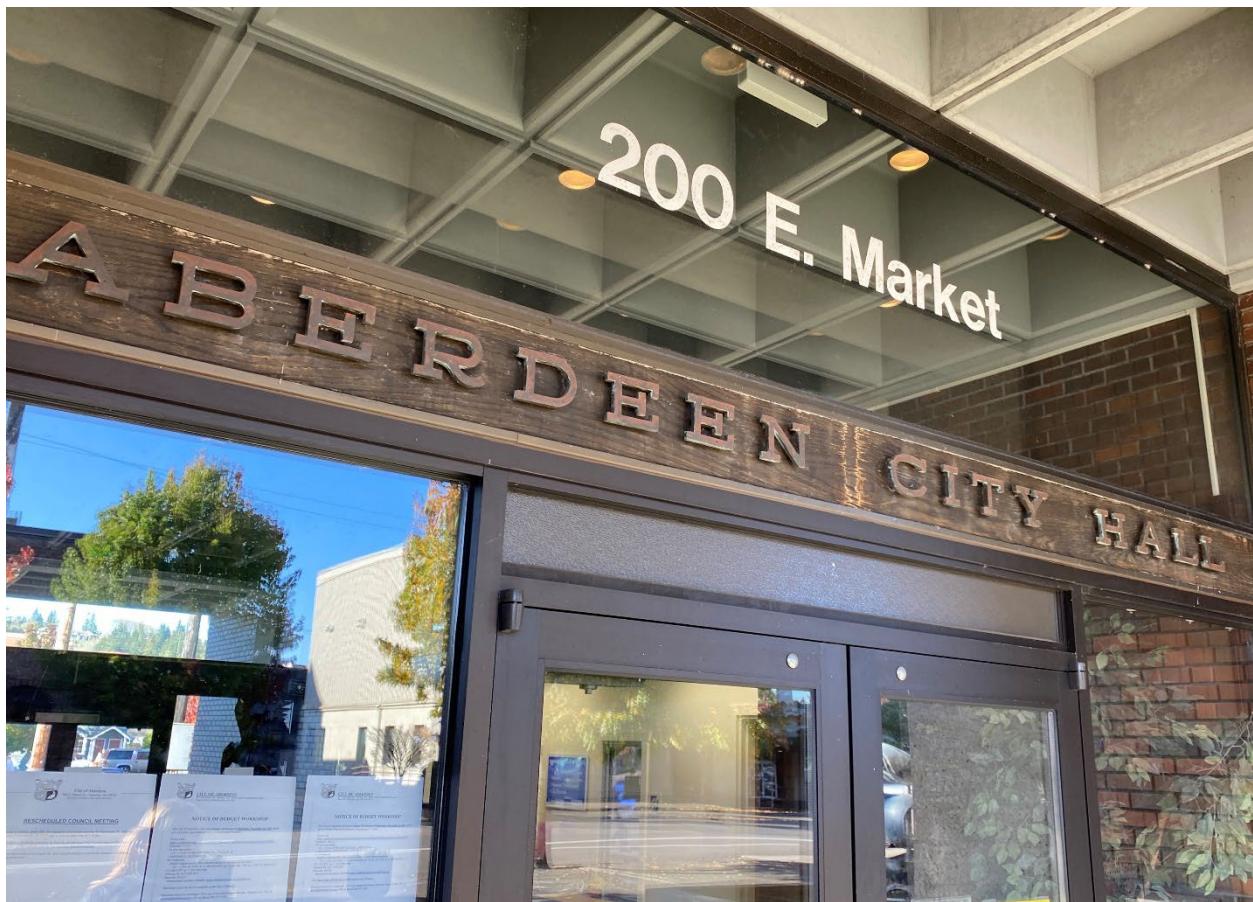
There are no apparent signs of water intrusion, and the brick masonry exterior walls are in good shape. Some windows need replacement where the glass seal is broken, to improve energy efficiency. Caulking and flashing systems appear in good shape, though there is some build up of moss at the top roof level below parapet coping that should be removed during annual cleaning/inspections.

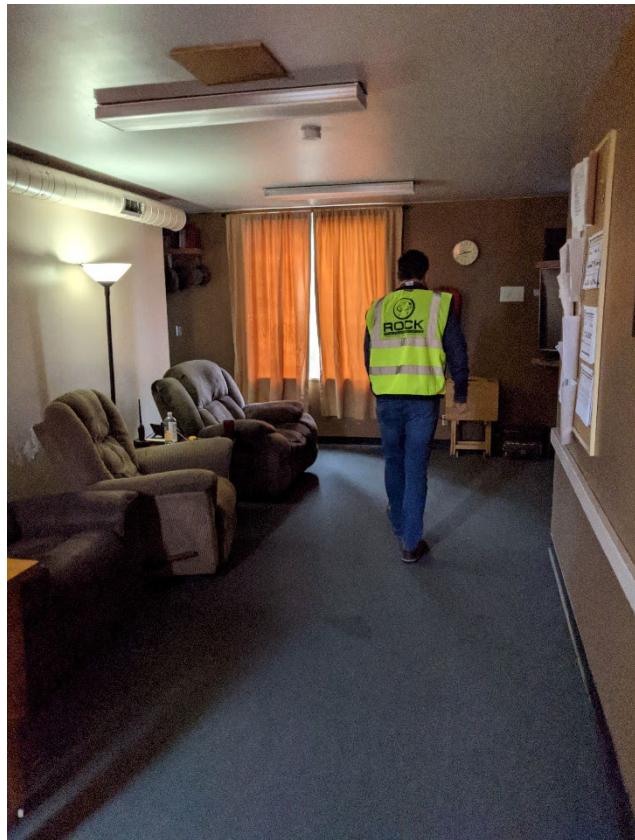
Many spaces are overflowing with equipment and gear in locations that are non-secured, and poorly ventilated.

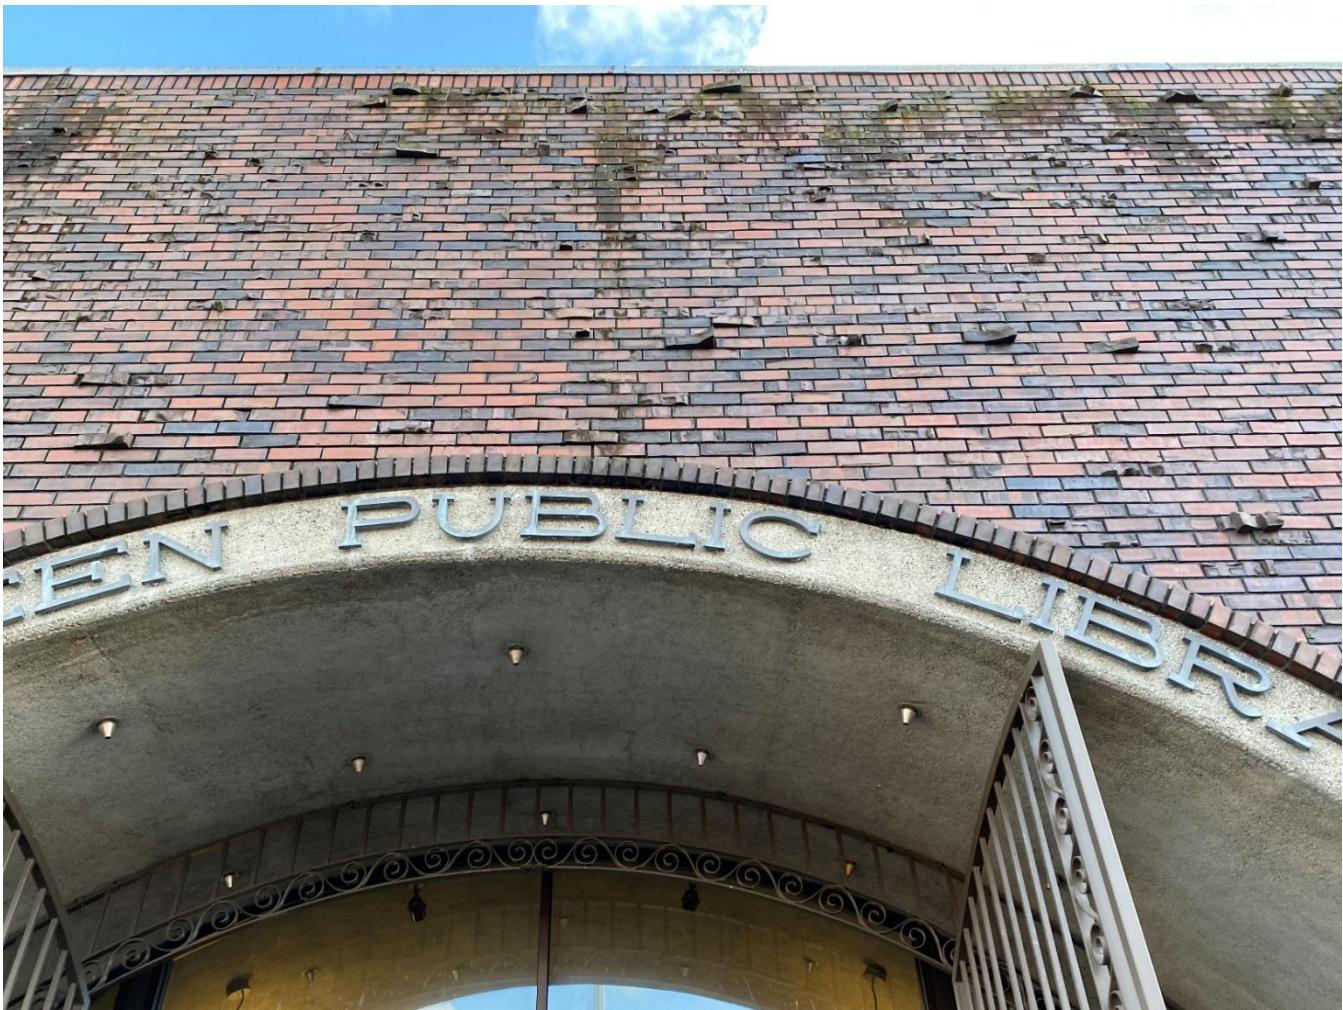
Aberdeen Public Library Entry and damaged brick facade

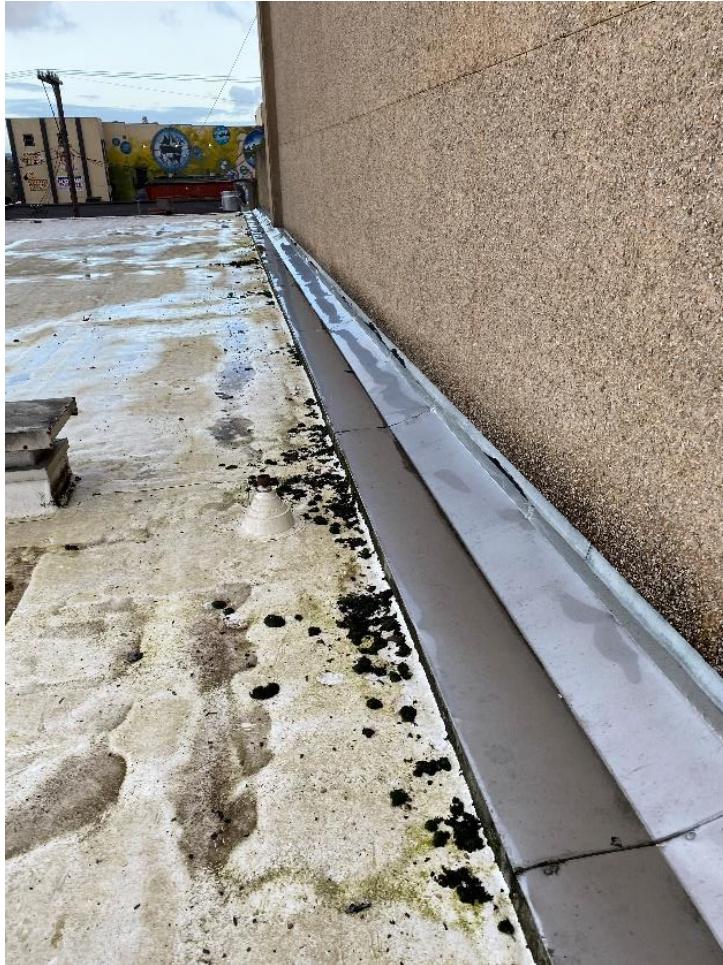
Library roofing membrane, skylights, some ponding water, mud on roof

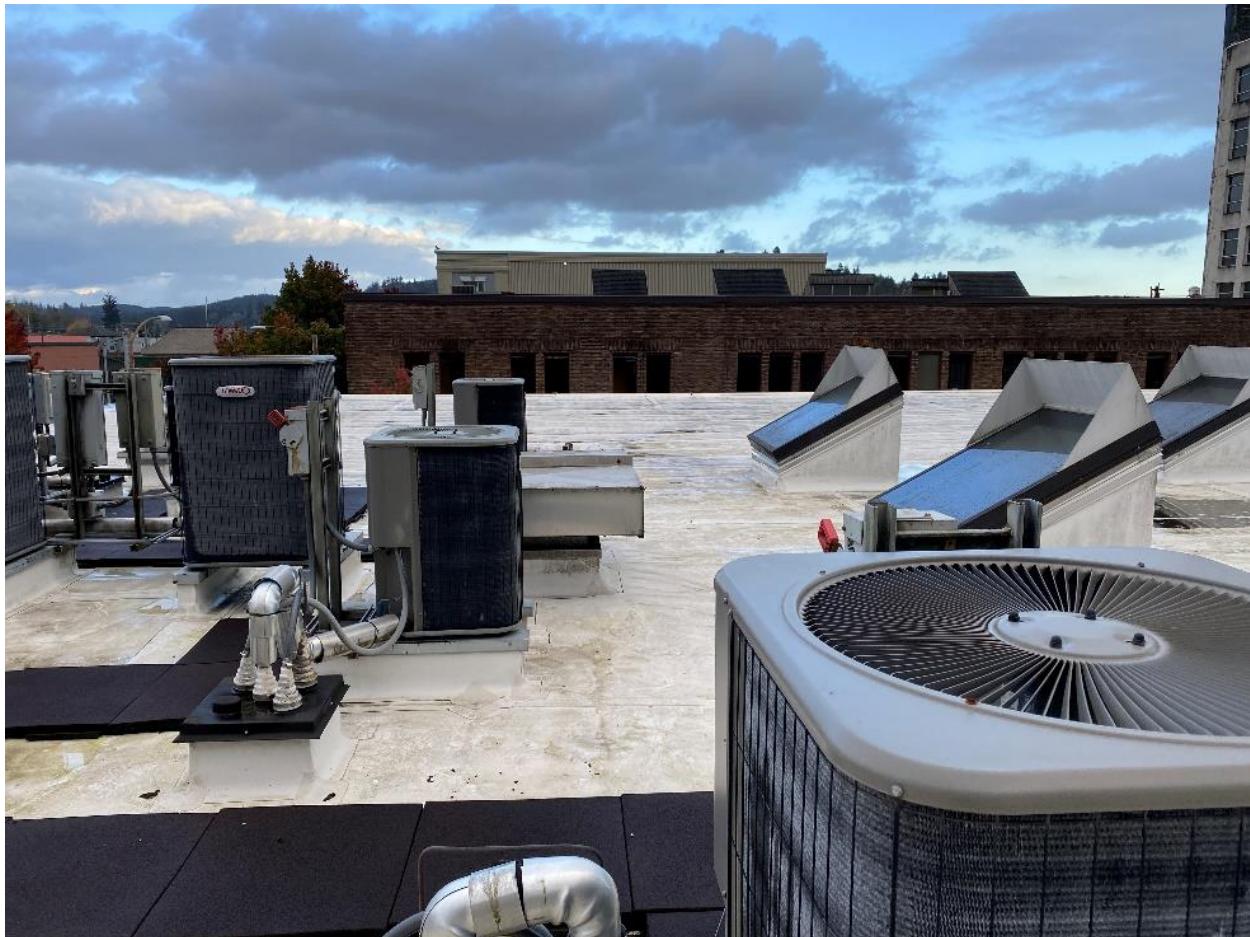
Debris left on roof membrane in several locations from maintenance crews

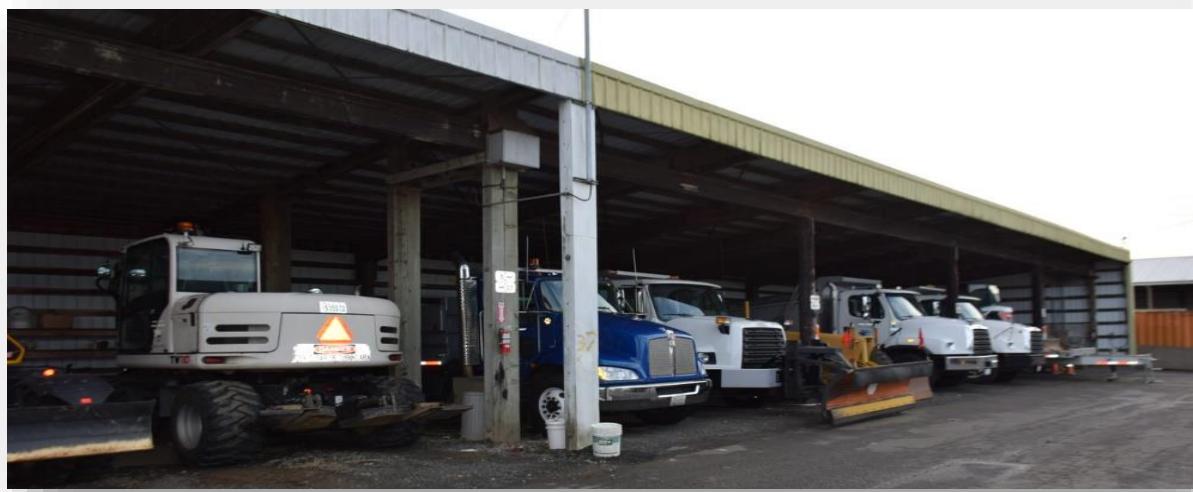
The “Lean to” provides covered shelter for Trucks and Street Equipment. The building isn’t deep enough to fit the longer trucks/equipment. Extending, adding roll-up doors, and enclosing the space with good ventilation will help to preserve expensive mobile equipment assets.

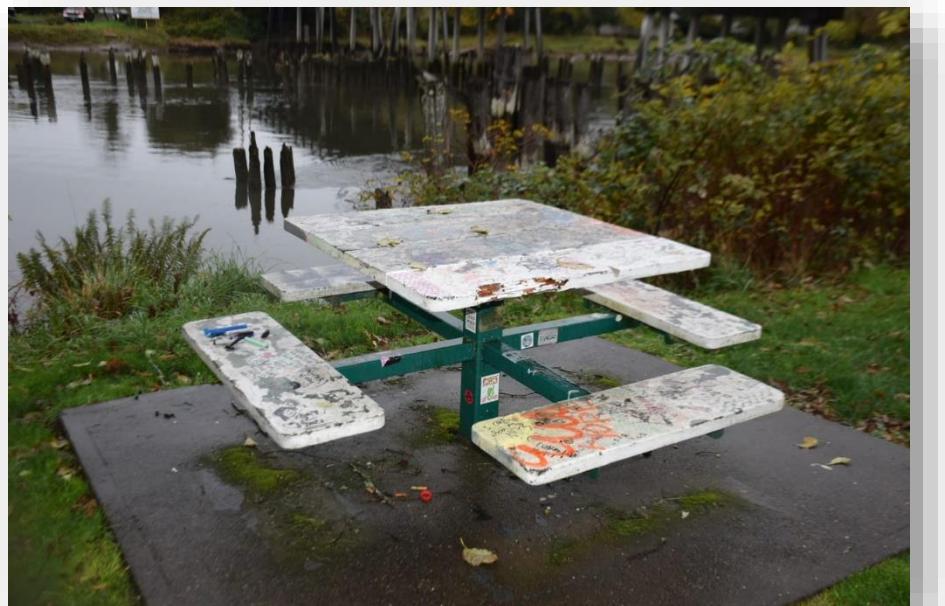
There is one table, and two benches in the Park. Each have many carvings and graffiti tributes to the musician, and not necessarily usable as places to sit, relax, or picnic.

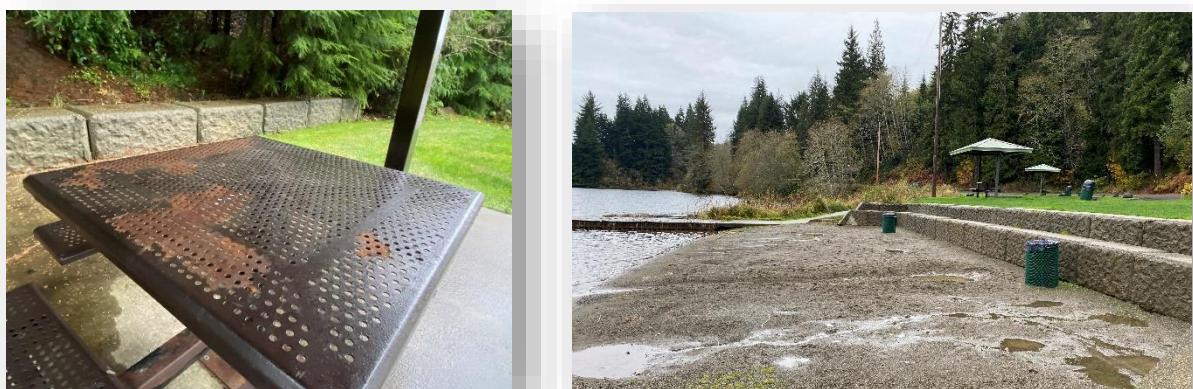
Lake Aberdeen Recreation Area – Metal picnic table showing signs of rust

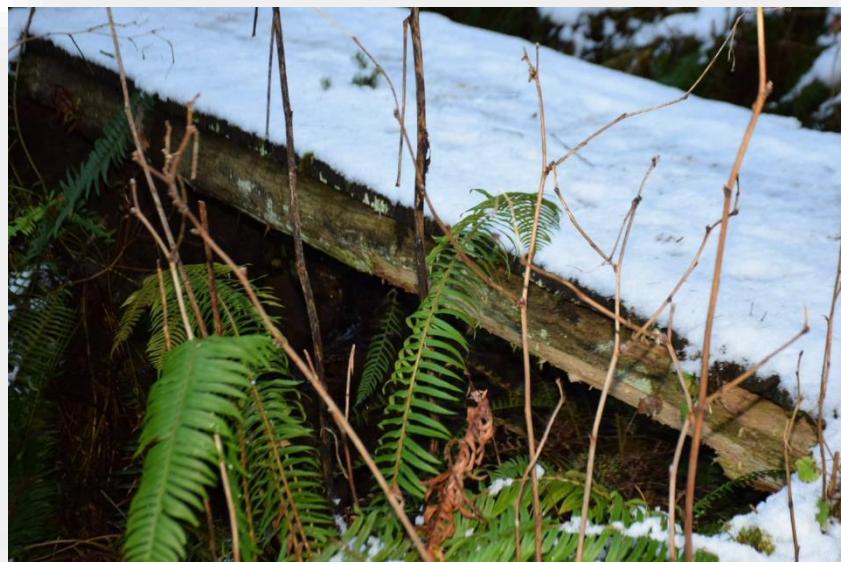
Stewart Park Trail is hazardous in many locations
