CITY OF ABERDEEN
CAPITAL FACILITIES PLAN

March 22, 2022

EXECUTIVE SUMMARY

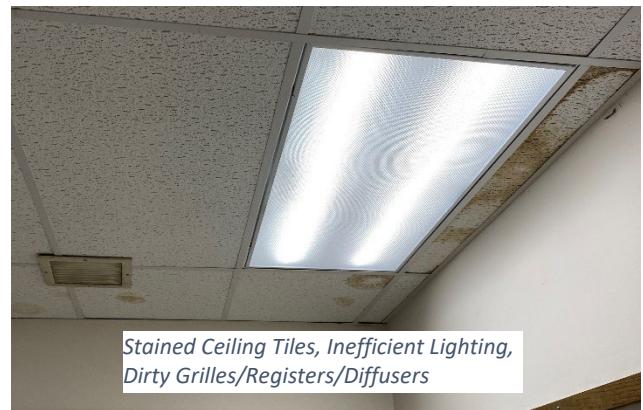
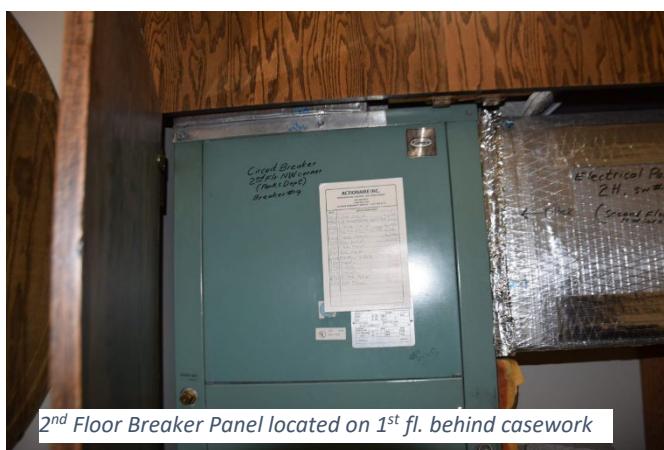
There are signs of overhead drain/condensate lines staining ceiling tile, and the grilles/registers/diffusers are dirty. Indoor overhead lighting is old and inefficient.

At the east end of the first floor is the “vault” that serves as a storage area for archives and city records. Shelving and high-storage areas need seismic bracing and files should be secured from toppling in a seismic event.

Data/Comm system is exposed and unprotected from potential damage.

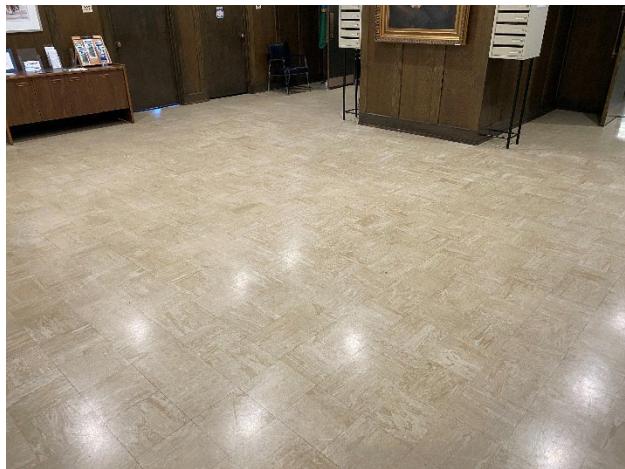
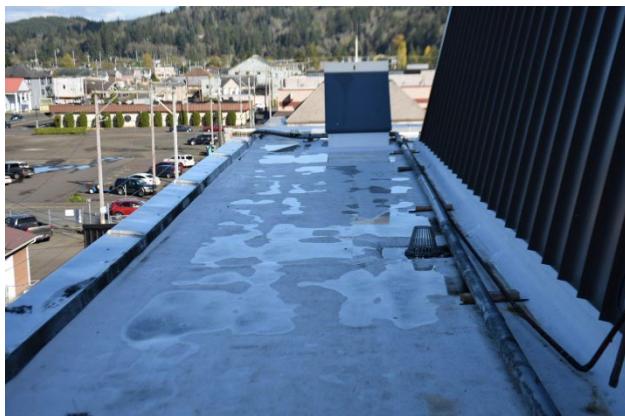
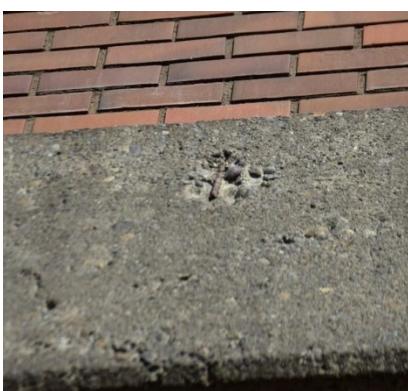
Roofing Conditions

The EPDM roofing system is in relatively good shape, and there are no signs of membrane compromise, but there are locations of ponding water, and the parapet height can let driving rain or snow buildup to get under the parapet coping and flashing systems, allowing water to enter the cavity of exterior masonry walls. There is no fall restraint system for work on the roof, and there are no maintenance crew walking pads. A fall restraint system should be considered for future maintenance work safety, and roof walking pads will protect the roof membrane from inadvertent punctures and extend the roof membrane design life.

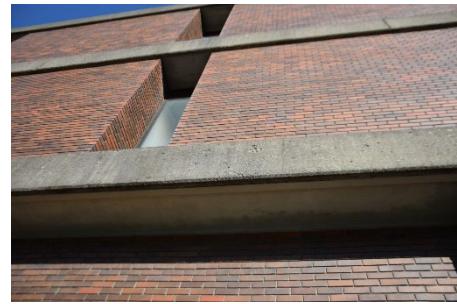
Exterior Building Enclosure Systems – Signs of Water Intrusion

The building is solid. There are no signs of settlement or cracking. Some minor concrete surface spalling was noted on the west exterior wall, second floor level, exposing rebar that will continue to rust and cause more spalling. An epoxy coating should be applied, and the spalling patched to avoid any degradation.

There are no apparent signs of water intrusion, and the brick masonry exterior walls are in good shape. Some windows need replacement where the glass seal is broken, to improve energy efficiency. Caulking and flashing systems appear in good shape, though there is some build up of moss at the top roof level below parapet coping that should be removed during annual cleaning/inspections.

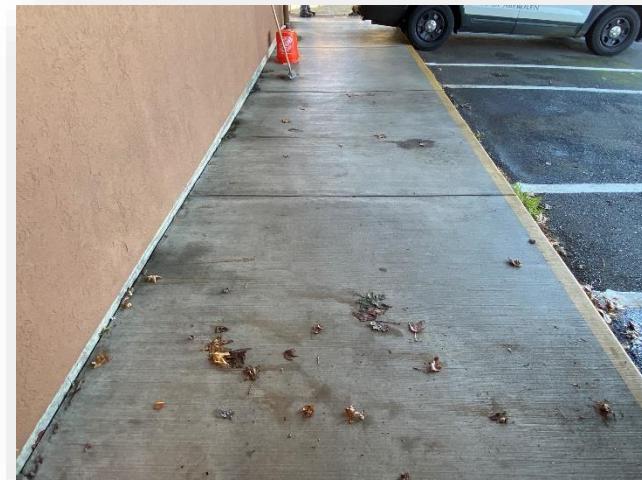
Police Headquarters – Site is settling away from structure

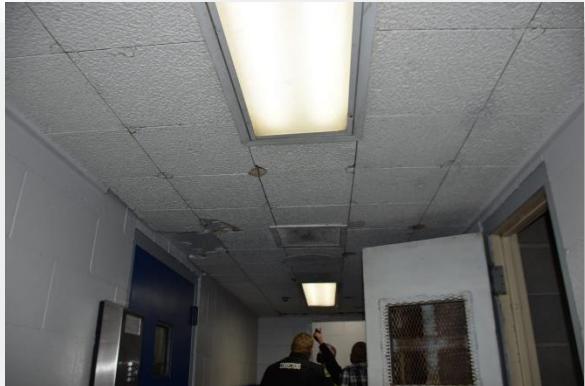
Police Headquarters – Failing systems, finishes

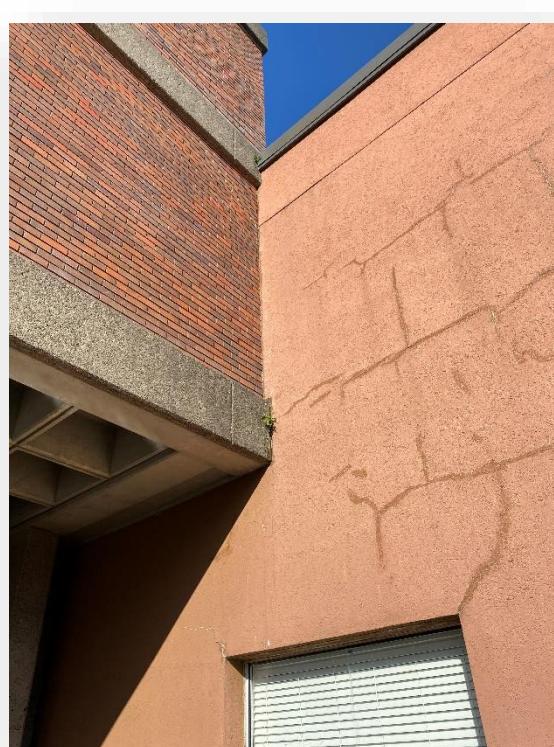
Police Headquarters – Stucco finishes failing, absorbing water and causing further decay

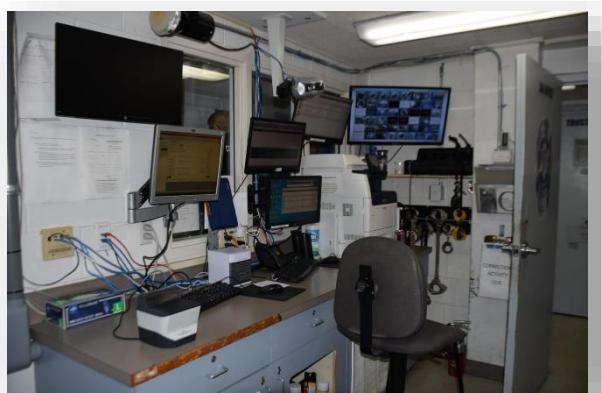
Police Headquarters – Poor, substandard working conditions

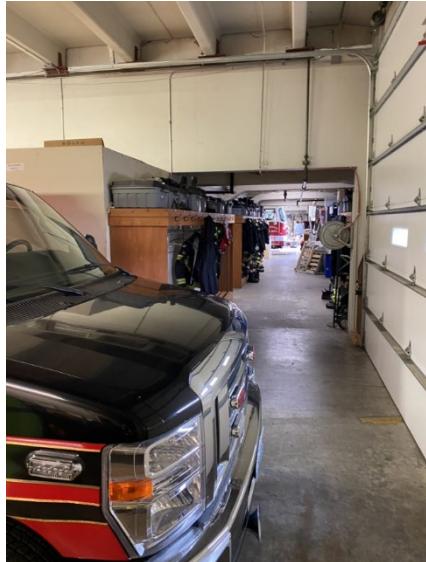
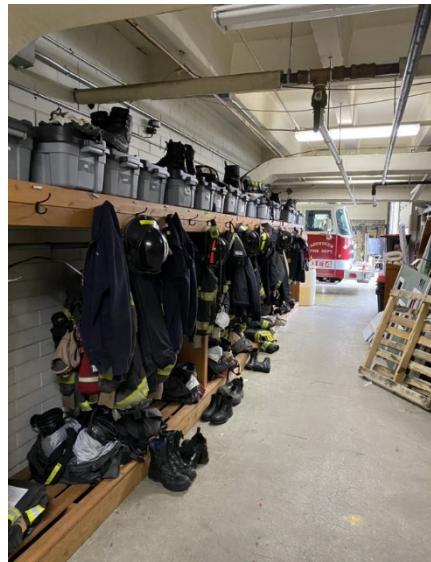
FIRST FLOOR PPE AREA SHARES VEHICLE BAY AREAS AND SAME HVAC SYSTEM

Vehicle exhausts are attached to an exhaust ventilation system, with automatic disconnect when fire units exit the facility. There is no separate building exhaust system for vehicle bays to ventilate exhaust buildup from time of disconnect, or from re-entry. The building does not include a ventilation system to address equipment off-gassing.

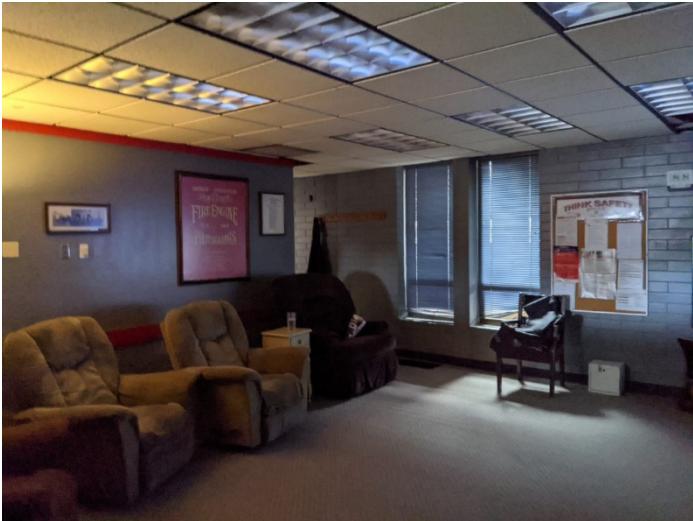
Firefighter Housing Areas – 2nd floor

The interior second floor includes firefighter housing spaces including meal preparation and eating spaces, personal lockers, sleeping areas, showers, and laundry. Leaking roof areas and mold have been observed, and ceiling tiles are stained with past and current signs of water staining. The interior spaces of the second floor are congested. Interior finishes and quality of accommodations are poor with substandard conditions for showering, laundry, food prep, and food services, and storage needs. Physical exercise equipment is located in a spare space adjacent to vehicle bays due to space limitations.

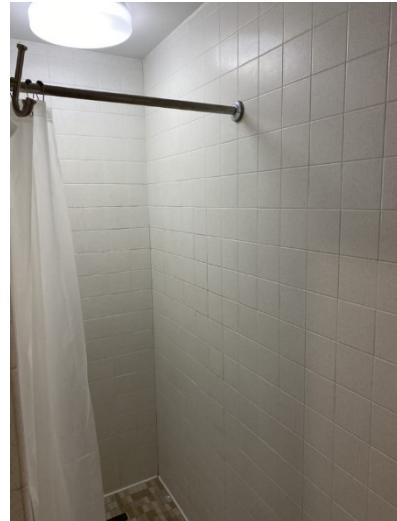
Shower Stall – 2nd floor

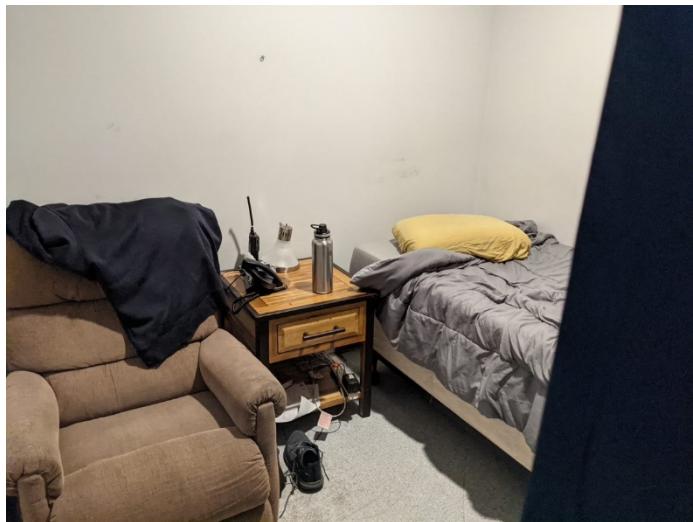
Firefighter Personal Sleeping Area – 2nd floor

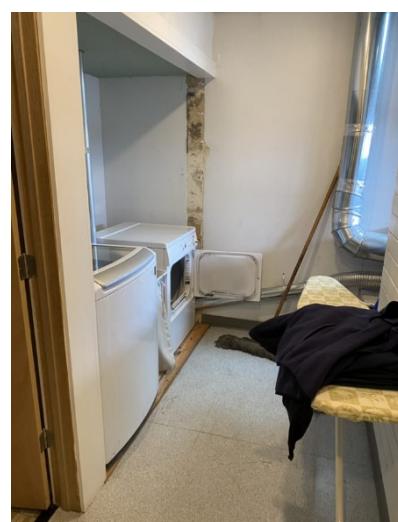
Firefighter Laundry Area – 2nd floor

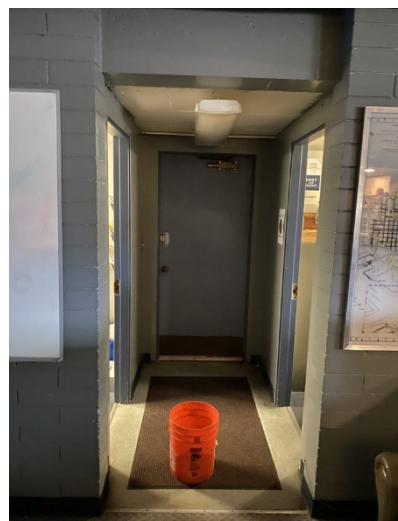
Firefighter Housing Area – 2nd floor
Note Bucket for Leaking Roof Condition

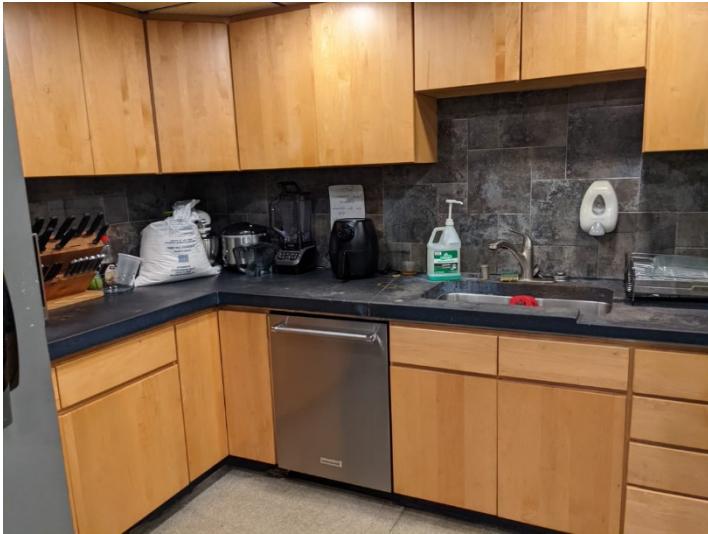
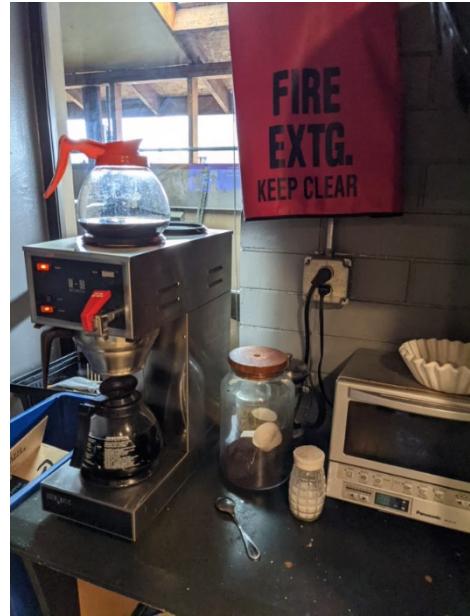
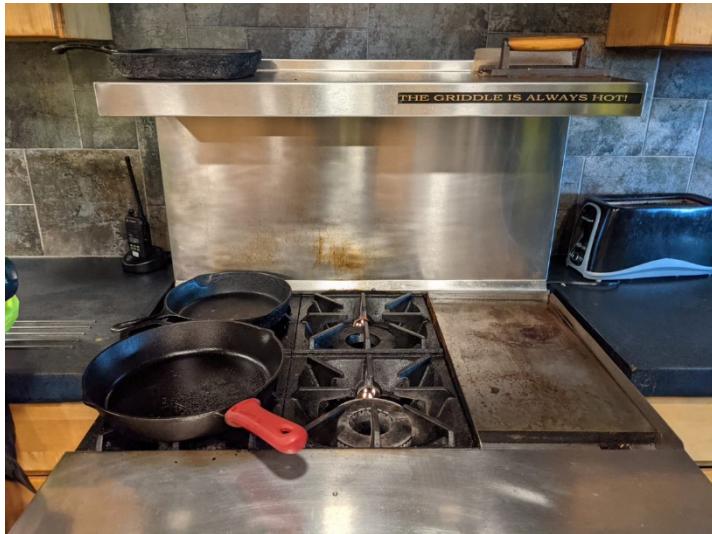
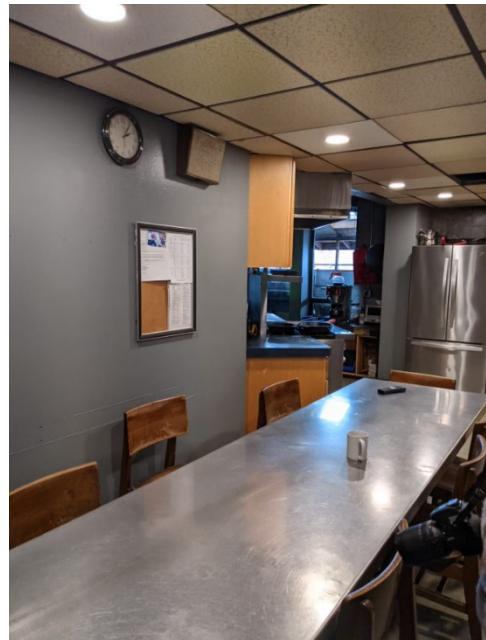
2nd Floor Meal Prep and Eating Areas.

The spaces show clear signs of 24/7 continuous use and substantial wear and tear to equipment, furnishings, and finishes, though some areas have had minor improvements over the years. The spaces for firefighters are poor and fall well below industry standards for housing accommodations for firefighters. Collaborative gathering areas, communal meal preparation and dining, and separate personal spaces are unacceptable by industry standards.

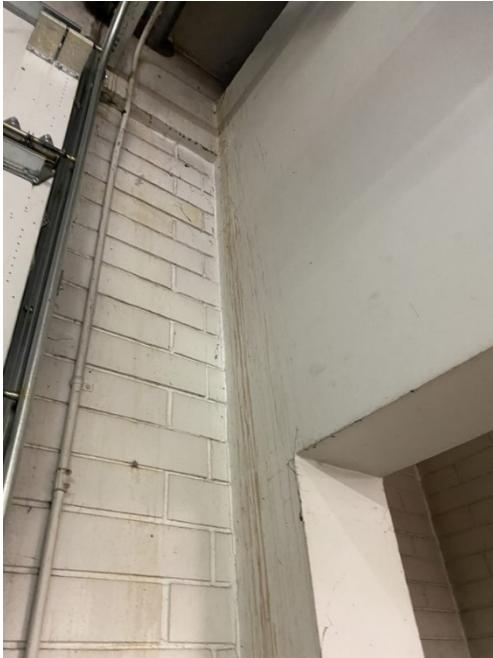
Signs of Water Intrusion – Engine Bay

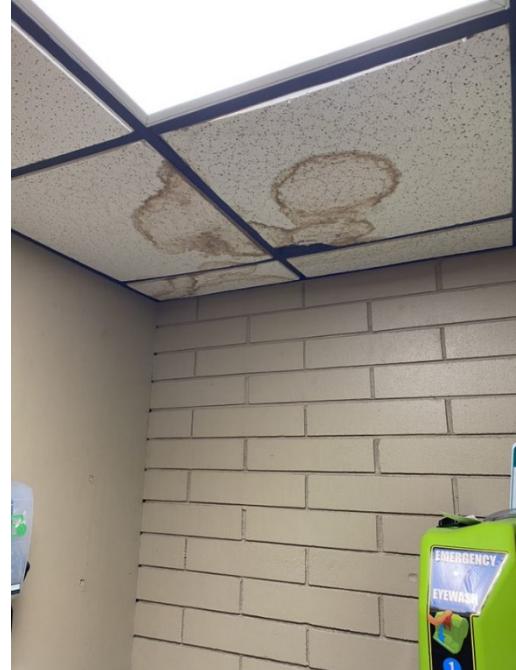
Typical Ceiling Tile Damage from Water

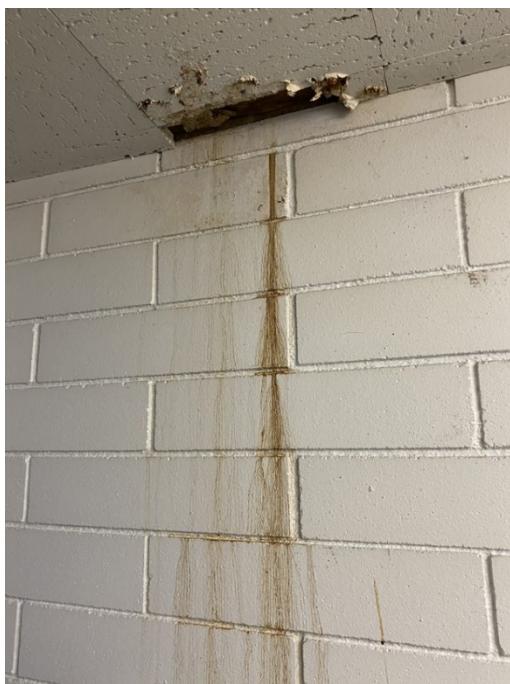
Signs of Water Damage

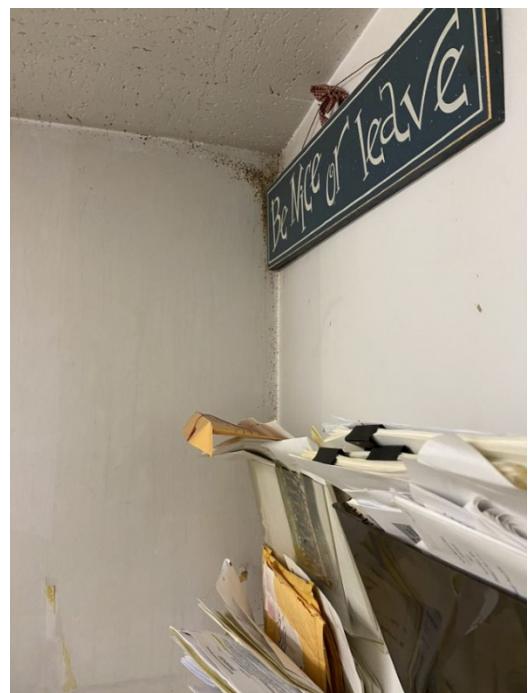
2nd Floor Office – Signs of Mold

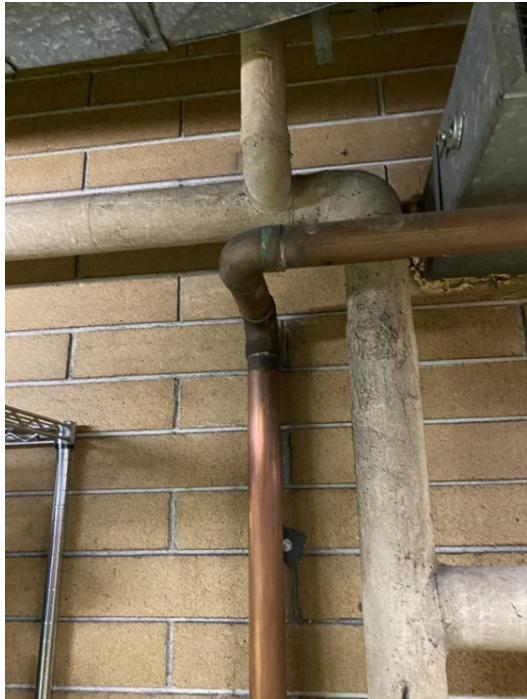
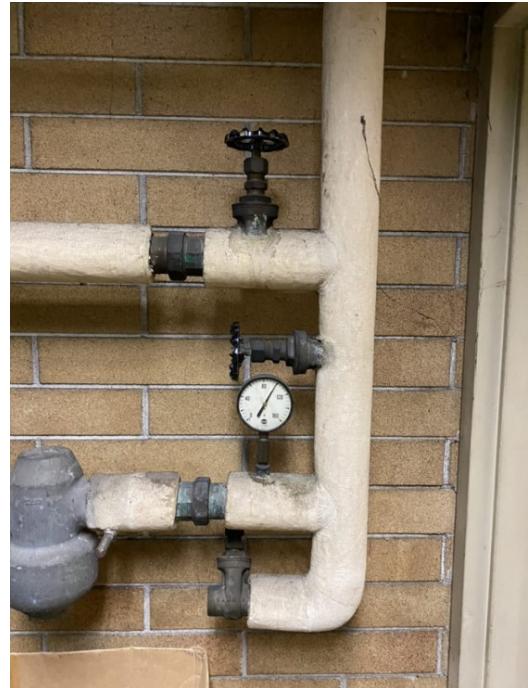
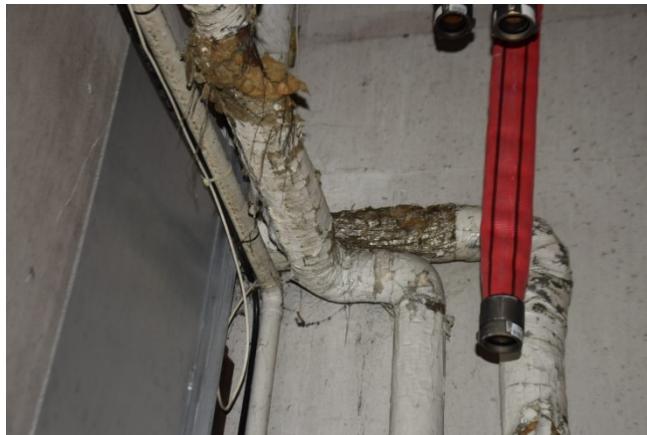
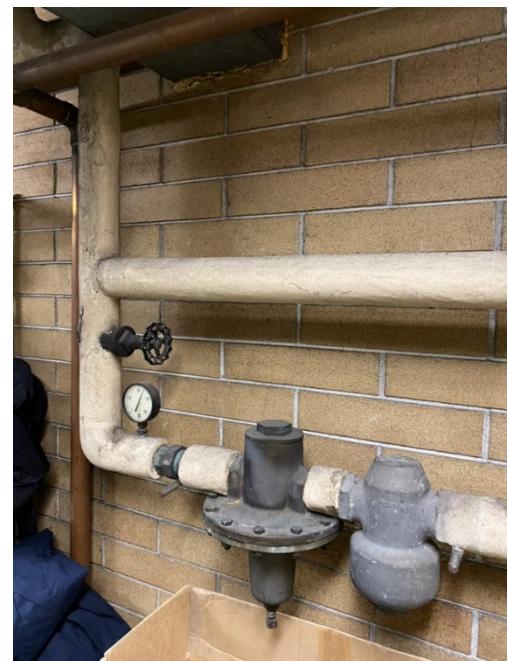
Suspect Asbestos Containing Materials

These photos show pipe insulation conditions. “Plaster appearing” pipe insulation elbows are suspect asbestos containing material (ACM). The pipe insulation should be inspected for ACM, and if asbestos is detected, abated and replaced with non-asbestos containing insulation.

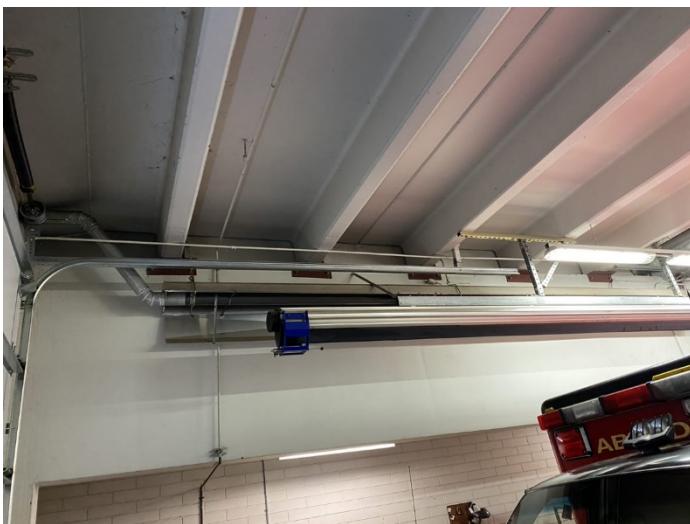
Seismic clips for structural, seismic upgrades appear to have been completed in previous years.

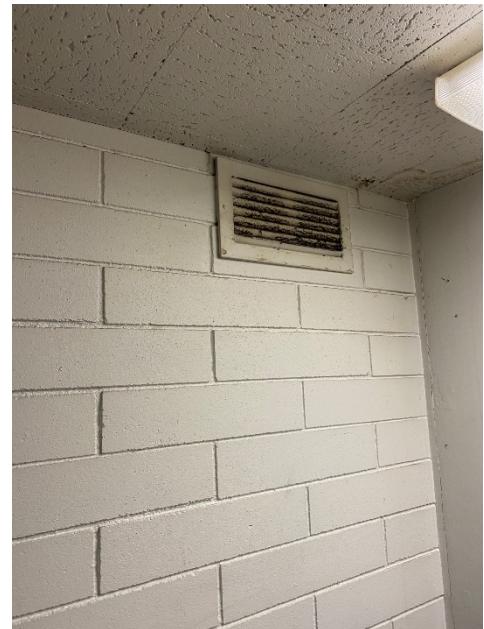
Grilles, Registers, and Diffusers are substantially dirty, which is a sign of poor indoor air quality, lack of proper maintenance, and age of HVAC equipment.

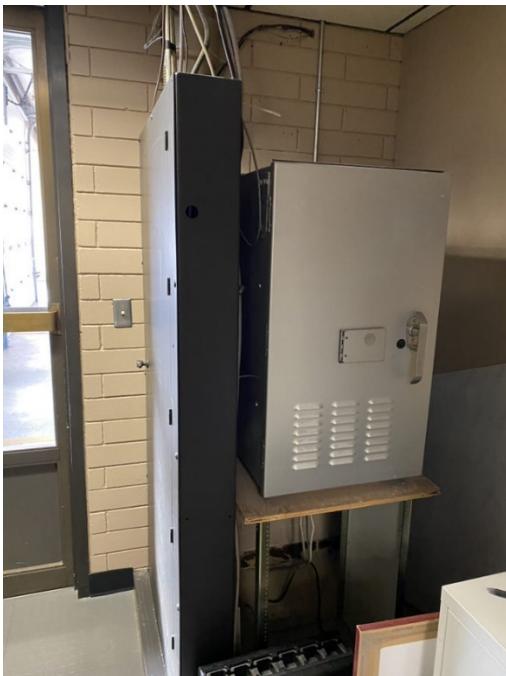
The low voltage data and communications systems are not secured and are located in an open area subject to damage.

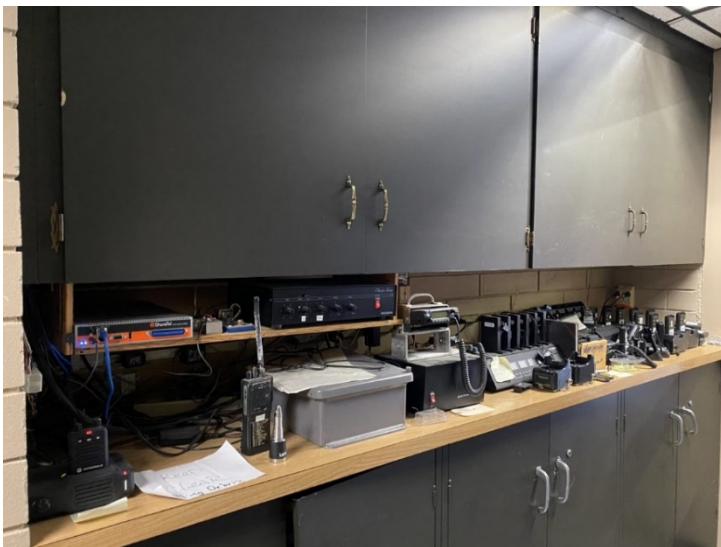
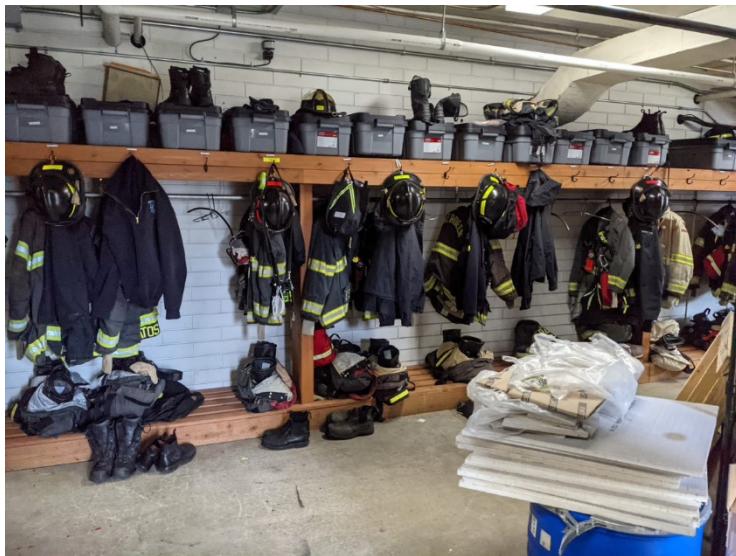
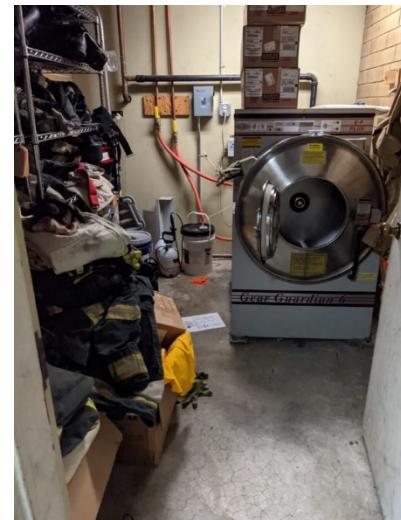
Storage and Congested Spaces:

This page shows photos that demonstrate a lack of storage throughout the facility. Many spaces are overflowing with equipment and gear in locations that are non-secured, and poorly ventilated.

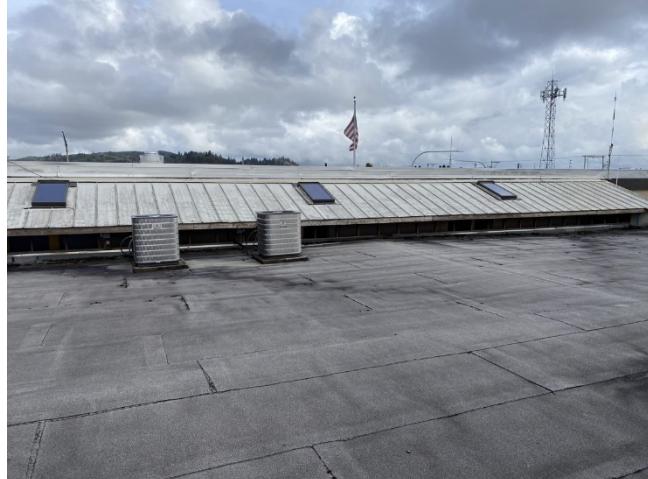
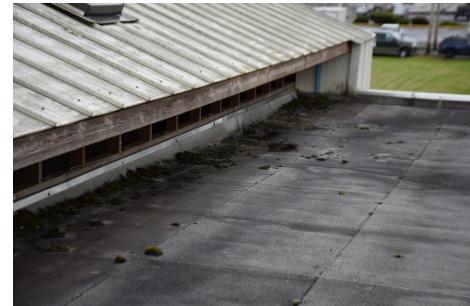
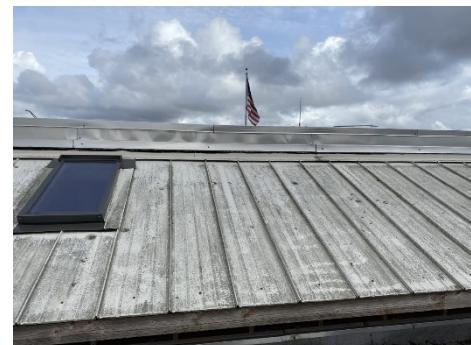
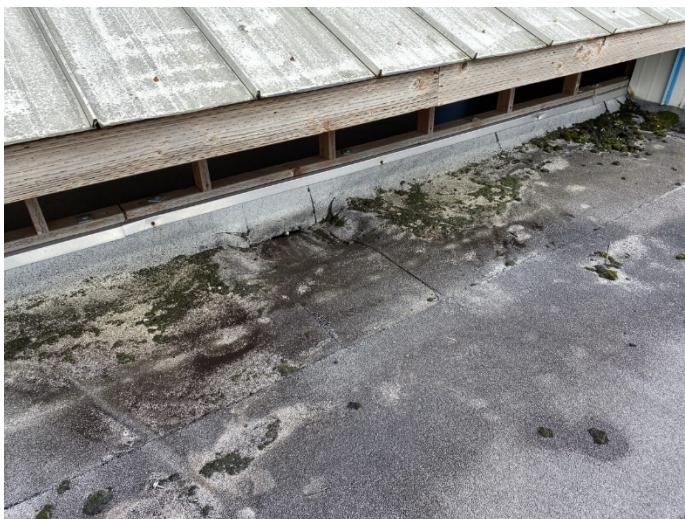
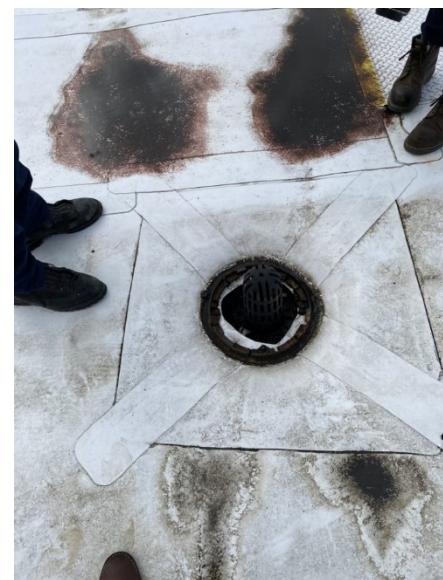
Roofing Conditions

The roofing system includes a combination of torch-down, EPDM, and metal roofing systems. Each system shows signs of system failure as indicated by roof leaks observed in spaces below those roofing systems. Low parapet conditions create opportunities for water, snow, and ice to migrate past counterflashing or coping areas. Flat roofs with minor sloping to drains cause more opportunities for standing water conditions for prolong periods, and allow more algae growth on roof membranes. A lack of overflow drains can cause water ponding if primary drains become plugged.

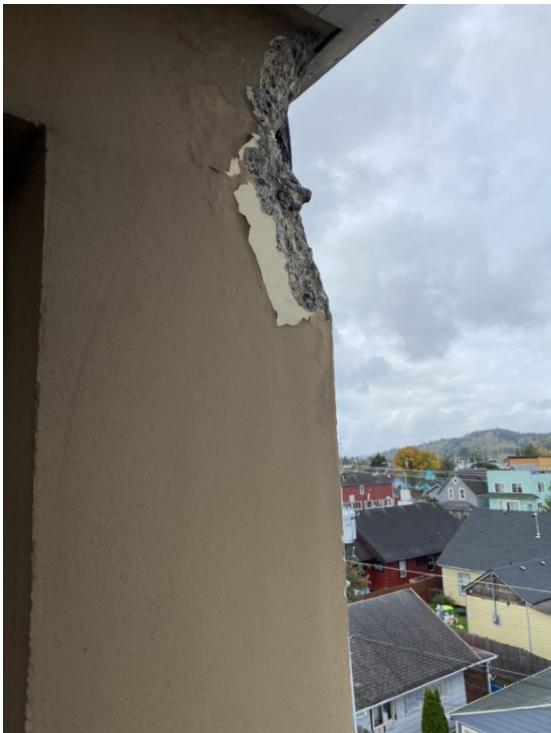
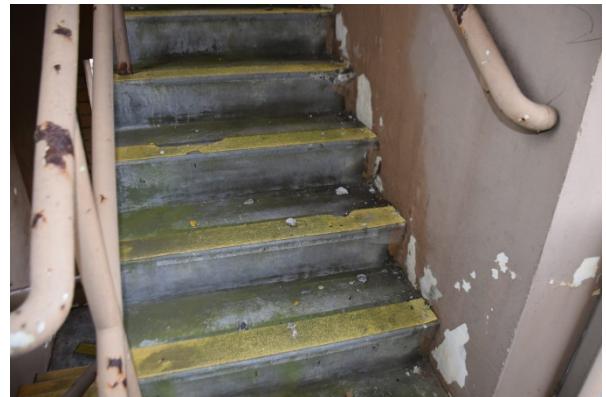
Structural Concerns – Hose Drying Tower, Stair Tower

These photos show concrete damage and spalling from water and ice intrusion. A concern that the tower could topple in a seismic event, and damage the remaining fire station facility is a concern. Other concrete spalling could damage roof membrane at the lower level, vehicle bays and general public in the adjacent alleyway.

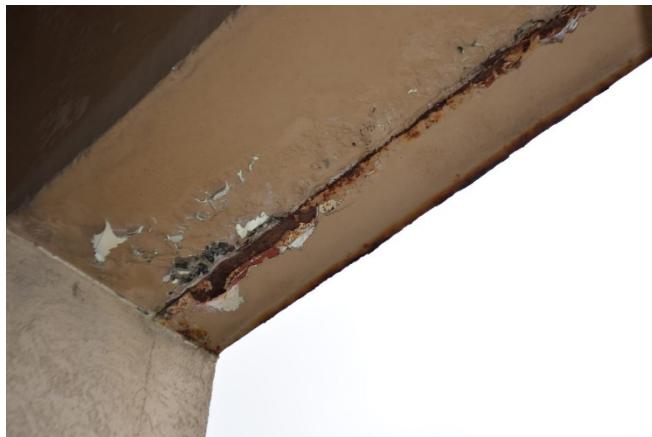
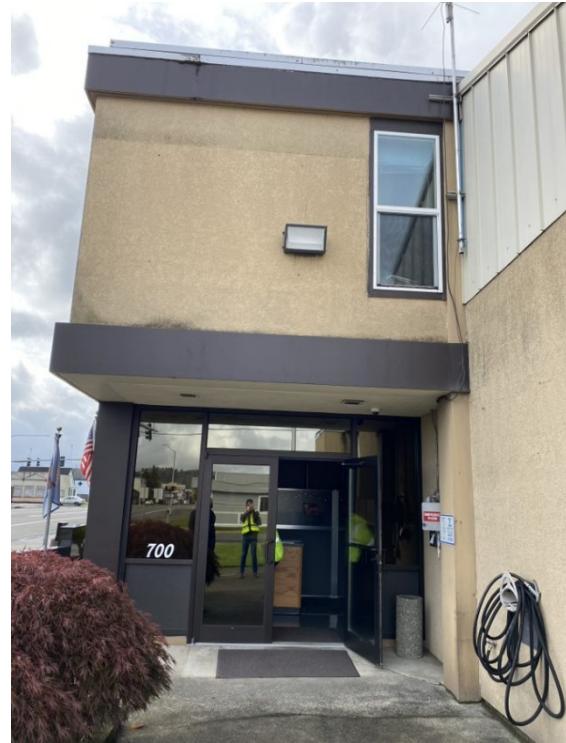
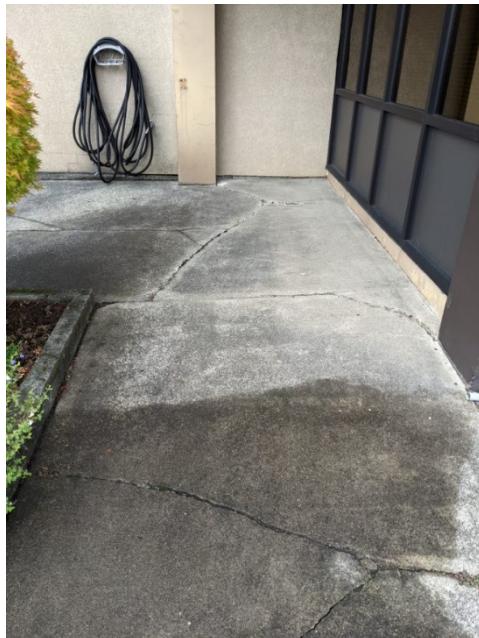
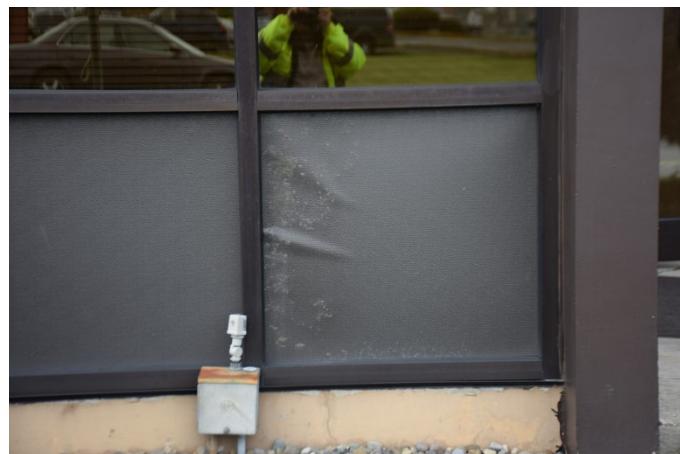
Exterior Building Enclosure Systems – Signs of Water Intrusion

These photos show signs of water intrusion and water damage to exterior wall building systems including wall panels, stucco systems that cover masonry substrates, and concrete paving that does not adequately slope away from the structure.

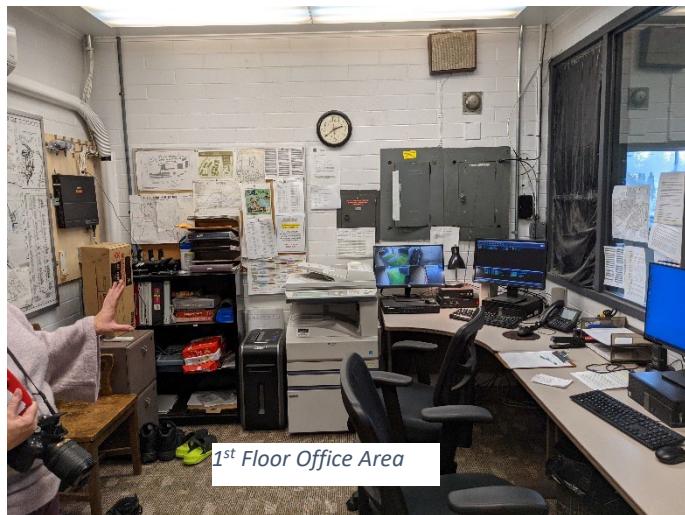
1st Floor Office Area

Fire Station Office Area. Immediately adjacent to the engine bays is the entrance to the fire station office area. The space is highly congested and serves multiple, competing priorities and creates an unsafe working condition for fire department personnel. The space should be isolated with an airlock vestibule to isolate diesel fumes and off-gassing from the engine bays into the office work area. Access to electrical panels is not code compliant. Data and communications are not secured, and the copier equipment should be located away from the immediate workstation with negative air pressure ventilation for indoor air quality purposes. Lighting and ventilation is poor.

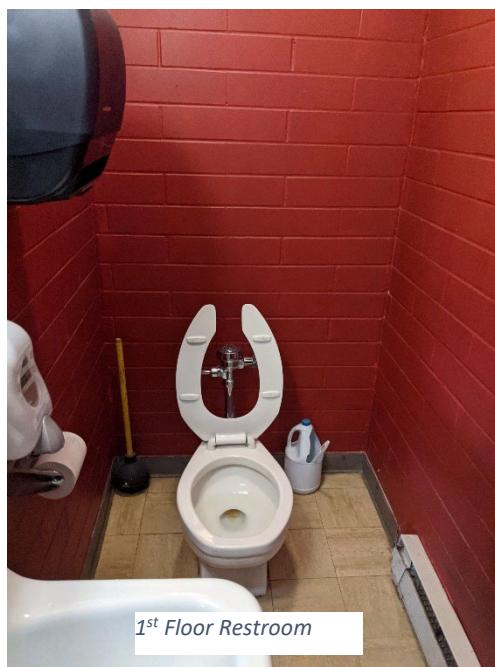
1st Floor Restroom

A small restroom (not ADA compliant) is adjacent to the office area with baseboard electric heat and poor ventilation. A set of narrow, steep stairs leads to the second floor.

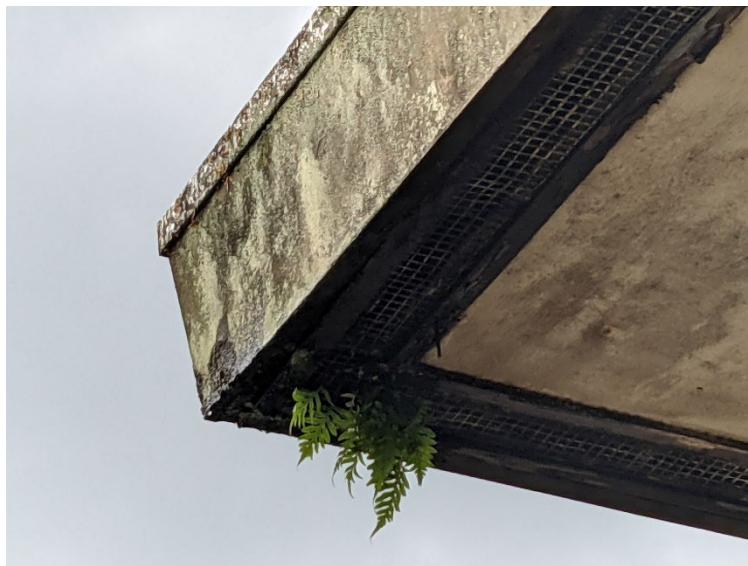
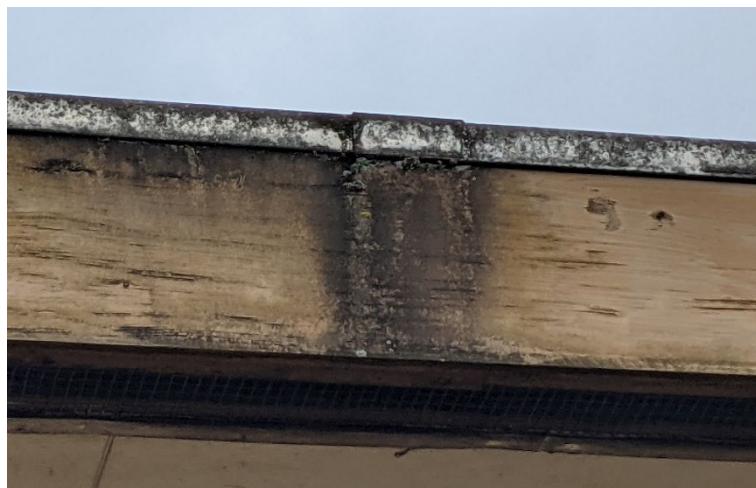
The mansard-style roofing system is unique. From original photos from 1966, the wood shake vertical canted upper roof has been replaced with metal paneling. The low-slope first floor roof is sheet membrane roofing and seams between membrane sheets and at intersection of vertical siding are areas where there appears cracking of membrane allowing water intrusion. The intersection of those two systems are points of roof system failure and the cause of some roof leaks that have occurred. There are built-in gutters that have failed and are likely the cause of roof water drainage on facial boards are causing dry-rot. Windows on the second floor need recaulking and are also sources for water leaks. The window seals and caulking between windows and metal siding are failing and not energy efficient.

The poor quality of the roof is exposing the roof structure to potential structural failure where water intrusion, mold, and mildew, and vegetation is growing.

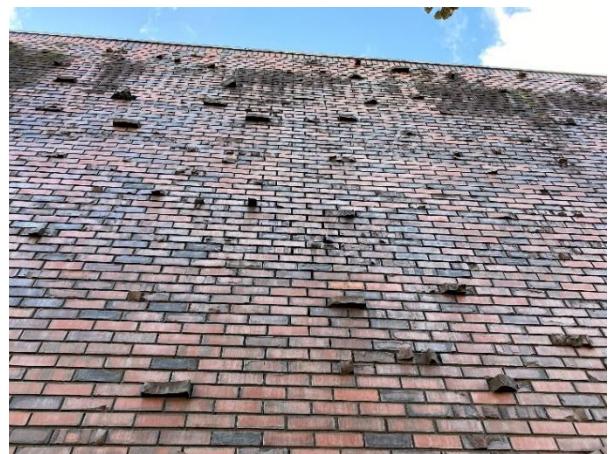
Evidence of brick veneer bulging, and damp white efflorescence on brick indicates cavity damage

Unfortunately, there is evidence of water not able to efficiently evacuate from the brick veneer cavity, as is evident from signs of moss, mildew, and efflorescence build up on the brick masonry. In some select locations, between steel relieving angles supporting vertical lifts of brick, there are signs where the brick stacks have expanded vertically from water absorption, but not adequate space from the top of brick stacks to the underside of the next higher stack is provided, causing the brick stacks to bend out from the face of the building. The cause of this is undetermined, but water intrusion into the brick cavity is likely a result of entry from the top of building parapet coping/flashings or areas where weep holes or internal flashings have been caulked over inadvertently over the years, trapping water in the cavity. Members of RPM's team has extensive experience with brick veneer systems, and based on our experience, the building brick veneer system is showing signs of failure and brick spalling and substrate structural support wall behind the brick veneer will start showing signs of structural degradation. Cleaning out brick weep holes and opening up any plugged internal flashing systems and ensuring top of wall parapet coping is watertight, are all important maintenance items that appear to have been deferred for several years and needs prompt attention. Vegetation at the ground level

planting beds should be cut back from the face of the building to help assist with allowing brick masonry to dry out. Soil built up and blocking weep holes should be removed to allow proper free drainage.

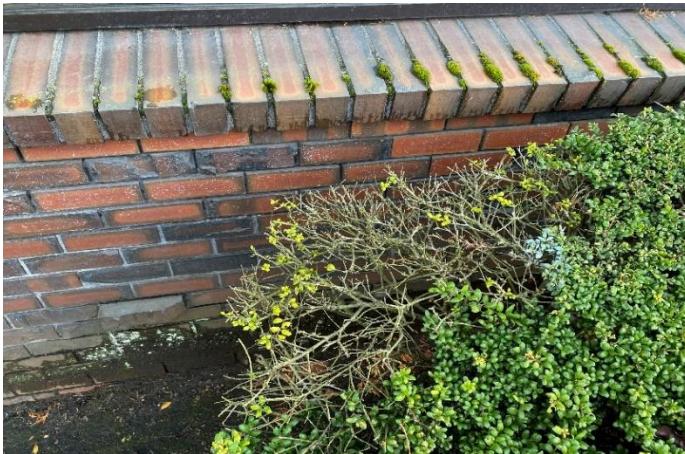
Brick base and soil/vegetation against masonry

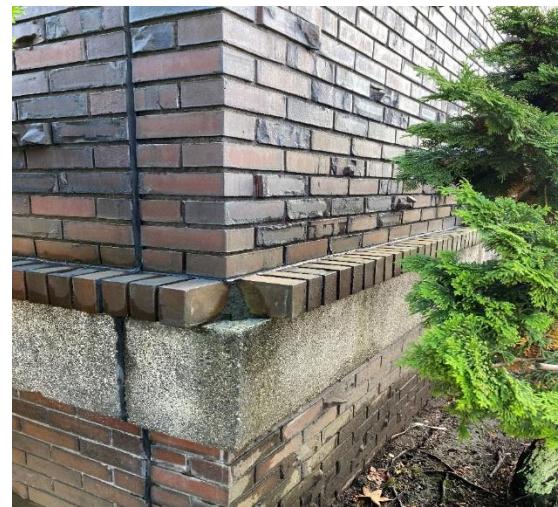
Brick veneer expansion joint. Missing broken brick ledge

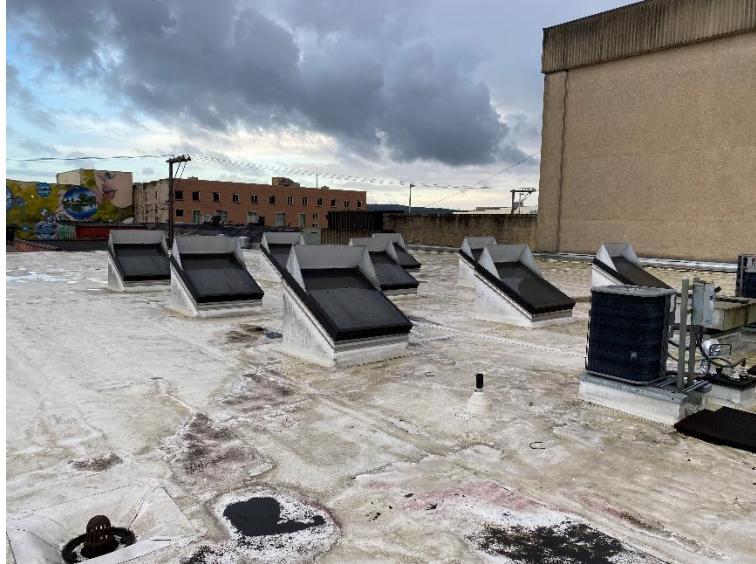
The roofing system is in relatively good shape. The EPDM membrane has some standing water and soil in some locations, but all membrane joints and seams appear to be in good shape. Some maintenance debris was identified on the roof and RPM staff removed the items (screws and some sharp remnants from HVAC work were removed so the sharp objects didn't blow off the roof and injure others below or fall onto the roof membrane and cut the membrane creating future roof leaks). The roof assembly includes several skylights. All skylights appear to be functioning as designed and flashing systems and curb canting

Library roofing membrane, skylights, some ponding water, mud on roof

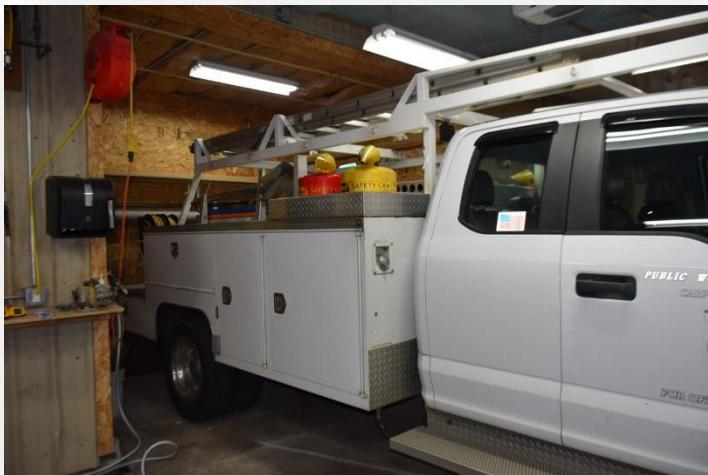
*Carpenter's Shop (mobile office vehicle) Adapted to fit truck in space.
Recommend vehicles not be located in occupied shop areas.*

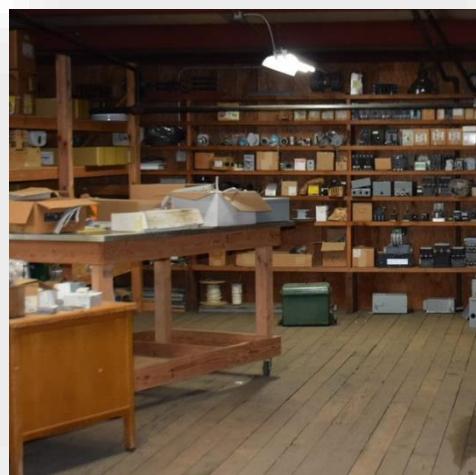
Carpenter Shop is well-organized.

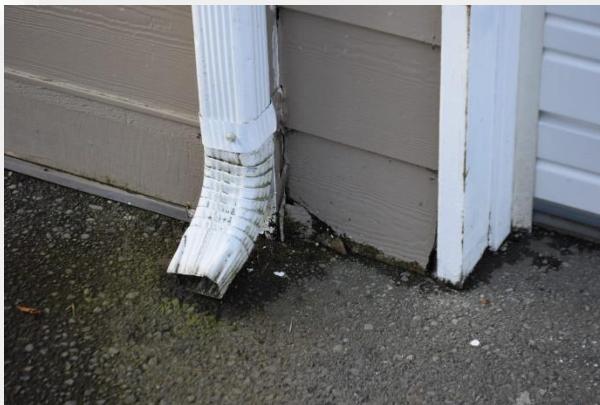
Downspouts in several locations are not channeling water away from building as needed

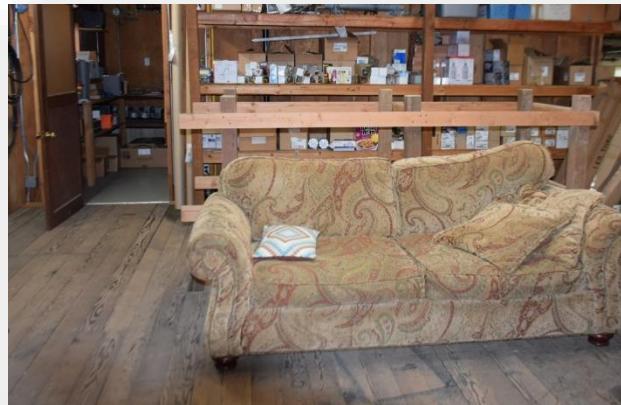
Electric Shop Loft Area – Serves as Storage and Breakroom, and innovation of staff to maximize space utilization

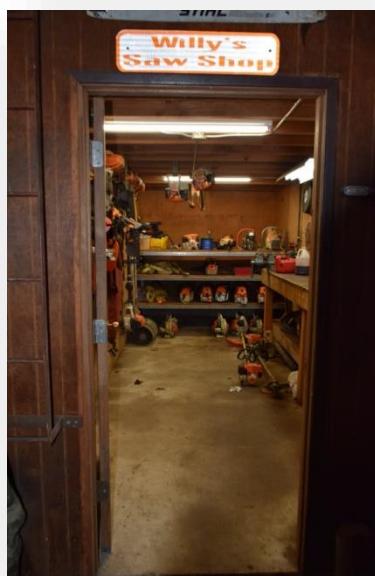
Saw Shop is well-organized

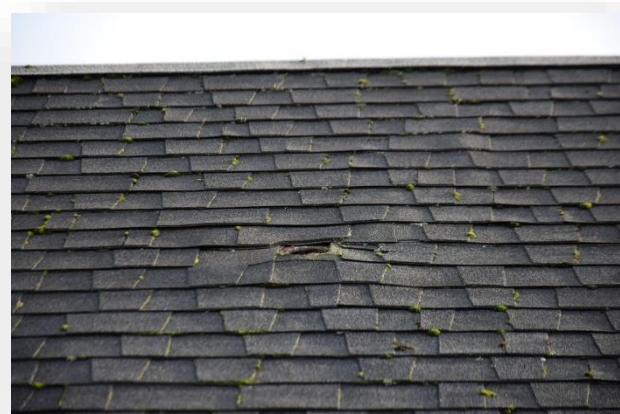
Roofing of Barn Building needs patching and eventual reroof. The Barn is structurally sound overall

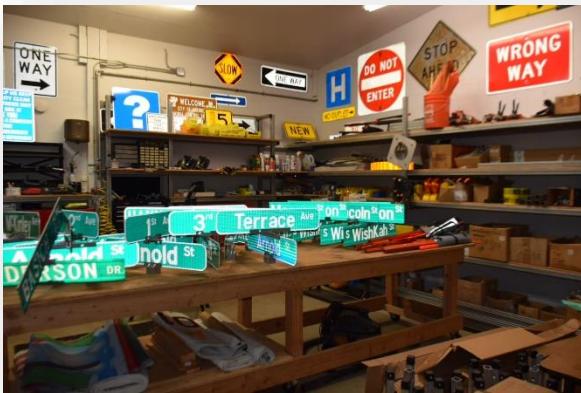
Sign Shop is small and efficient, and well-organized

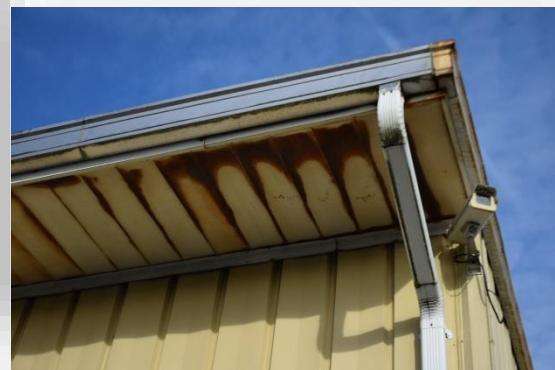
Each building exterior is showing signs of age. The metal siding shows signs of water intrusion in several locations on each building.

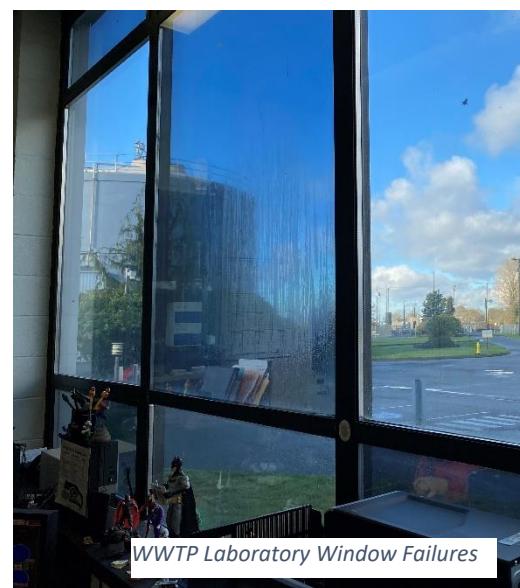
WWTP Laboratory Window Failures

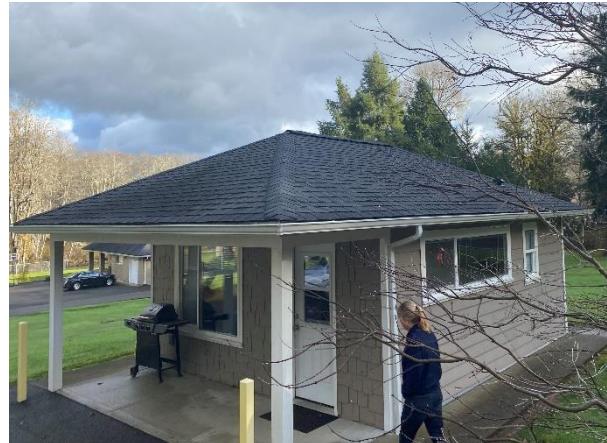
Employee Workroom, Breakroom and Restroom Facility

Facility and associated site and outbuildings is Good. The diversion gates from the Wyncote River and all buildings and grounds are well maintained. It is evident that the onsite groundskeeper is providing quality maintenance to this facility and the site. It would qualify as a City Park because of its natural beauty and open space. The main facility has operable windows to allow ventilation into the structure. There are some signs of musty dampness in the building but overall, the structure is solid, roof is in good shape, and the facility is clean and functioning as designed.

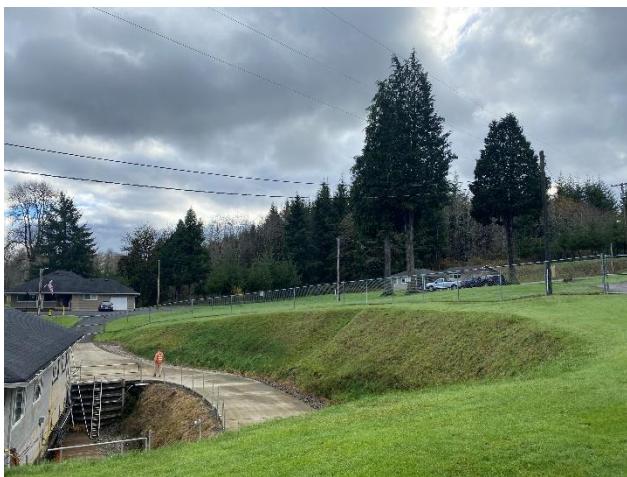
Industrial Water Facility Grounds – well maintained
