CITY OF ABERDEEN
CAPITAL FACILITIES PLAN

March 22, 2022

EXECUTIVE SUMMARY

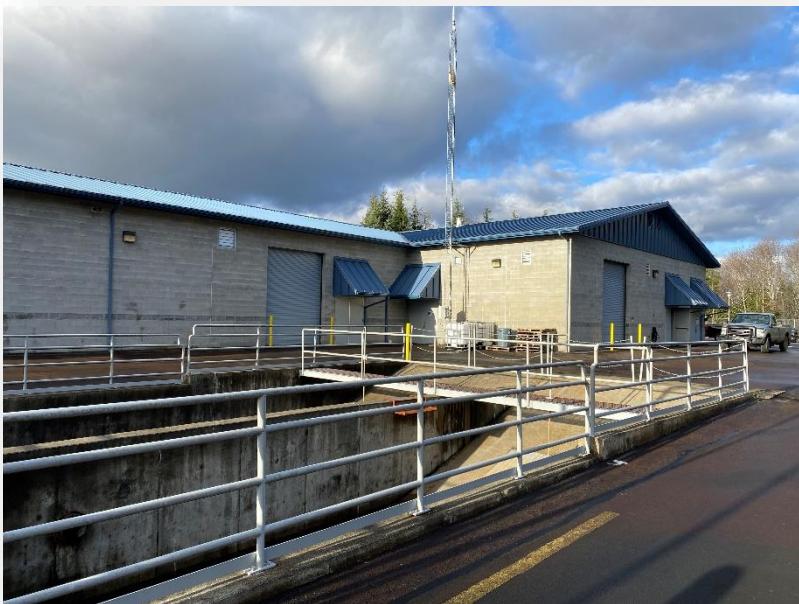
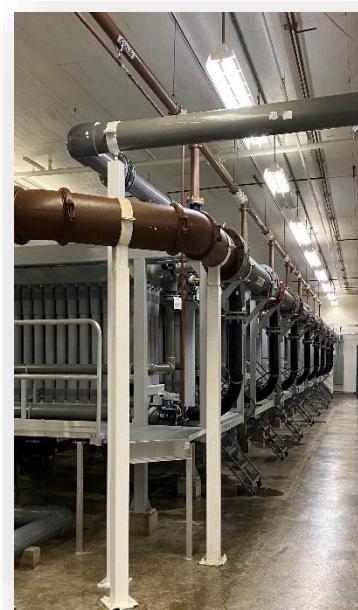
Findings and Recommendations. The building is approximately 22 years old. It is in remarkably good shape as a result of the small staff that supports the continuous operation at the facility. The exterior masonry walls have areas where caulking has come loose and needs to be reapplied. All equipment is working as designed and is well maintained.

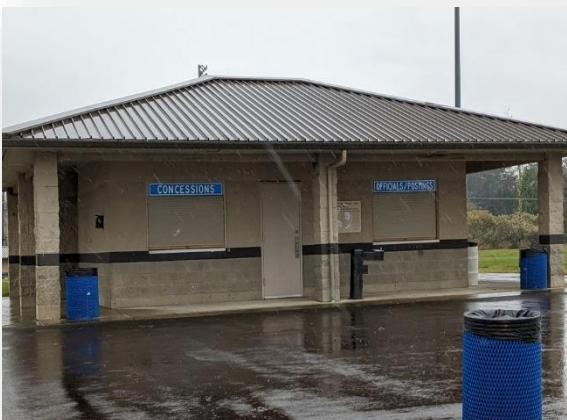
Biship Athletic Complex – Concessions Building

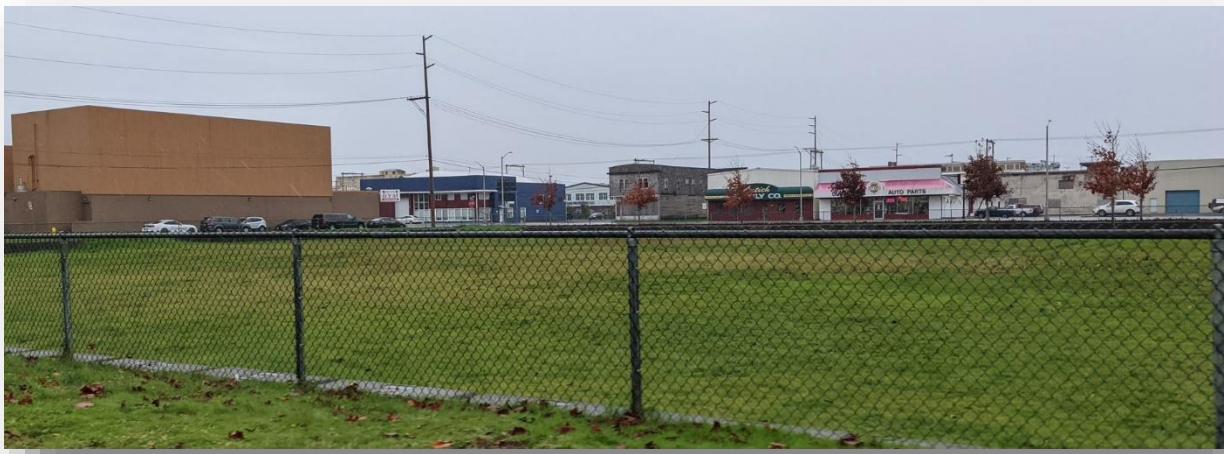
Franklin Field Reservoir and Ball Field – Looking SW

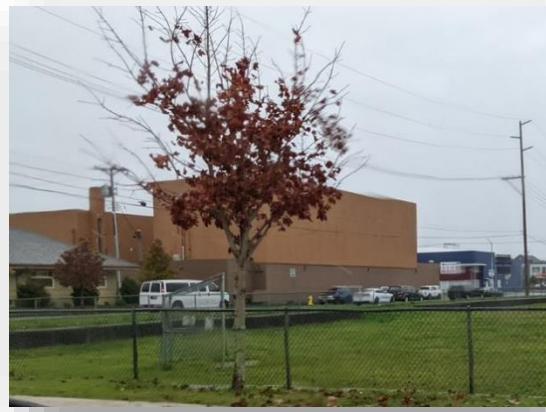
Franklin Field Reservoir and Ball Field – SE Entrance

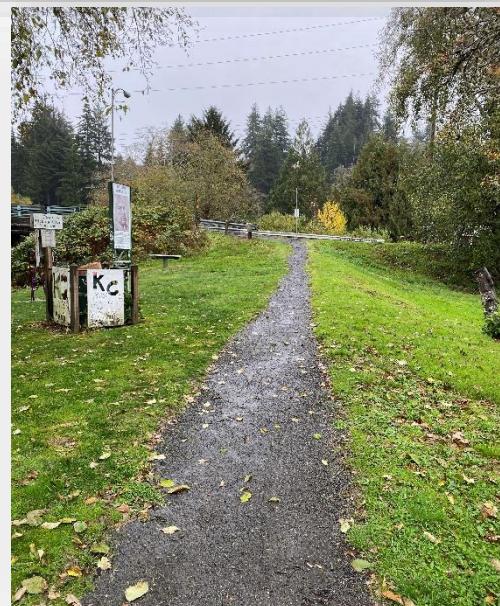
1. The Park trails are muddy, particularly along the trail to the underside of the bridge. Access is far from ADA standards and can be dangerous to reach the underside of the bridge where many visitors wish to see, as it was where Kurt Cobain would frequent as a young musician and wrote about his time there. Fresh gravel and clearing of sticker bushes should be considered to keep the natural, rough condition of the space, while making it less dangerous for visitors.
2. The Park is at the end of E 2nd Street, a residential street with no designated parking for Park visitors. Signs posted by neighbors make it clear that they are not necessarily pleased with the drug use and needles left behind by visitors to the Park.

Access trail from Young Street to the Park

A more robust maintenance of the Park with modest graveled paths, and directional signage may help improve the Park's overall conditions and safety.

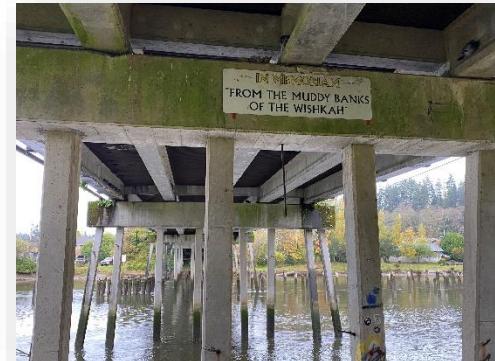
View of Bridge Underside, and River where the musician "hung out" as a youth

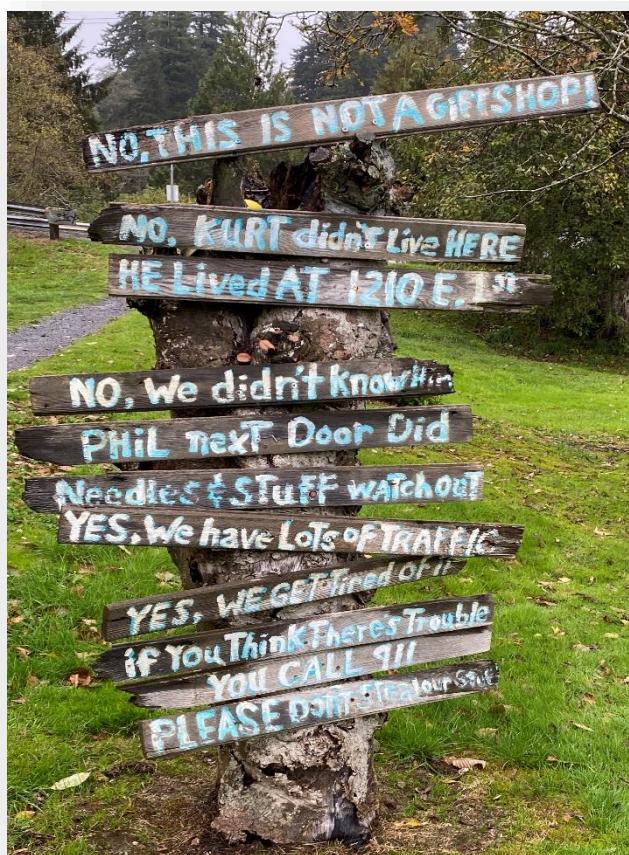
E. 2nd Street Neighborhood Entrance to the Park – Signage posted by neighbors.

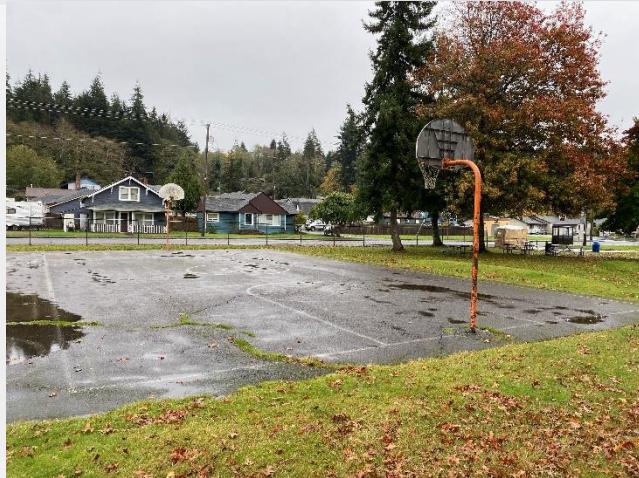
The overall condition of the North Aberdeen Playfield is Fair. The park has mature landscaping and needs a “refresh”. The basketball paved area is ponding water, and has ruts and weeds growing up through the cracks in the pavement. The basketball hoops are old and need replacement soon. The turf areas are rutted and uneven in many locations, and fencing is rusted and showing its age. The tables are in good shape, and overall, the Park meets the needs of the local neighborhood as a nice open area and a good place for a kid just to be a kid.

North Abedeen Playfield – Basketball sports court pavement, striping and basketball hoops need improvements

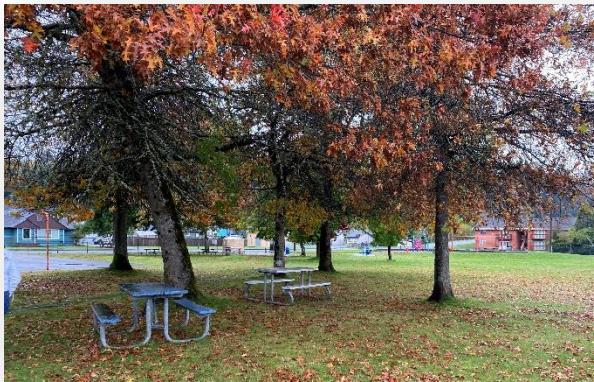
North Abedeen Playfield – Tree pruning needed

The larger trees need pruning of dead branches, and some of the old chain link fencing needs repair in several locations. The turf areas are uneven, and for a really good game of baseball, the fields could use some added attention.

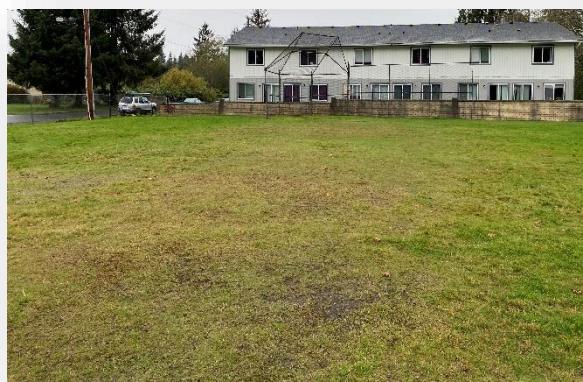
North Abedeen Playfield – Turf playfield is uneven and needs reseeding in areas

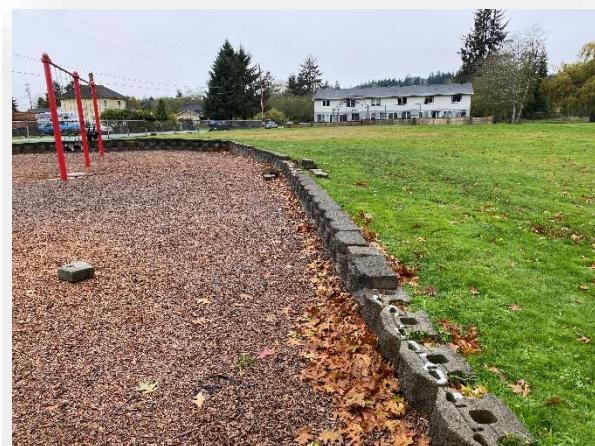
Some of the masonry blocks separating the children's play area from the turf areas have been removed and displaced, as shown in the photos, but generally speaking, this City park is in reasonable shape, could use some added attention, and is serving its intended purpose for the neighborhood.

North Abedeen Playfield – Split-face CMU blocks separating play area from playfield have come loose and need to be resecured.

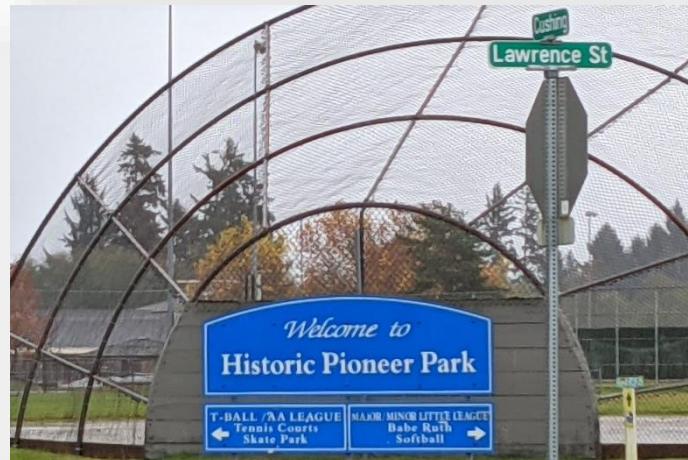
Historic Pioneer Park in South Aberdeen

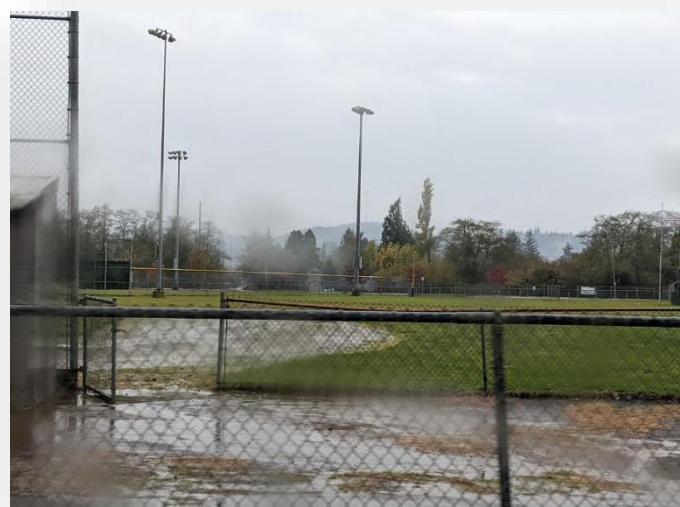
Pioneer Park – Photo of Sports fields on a rainy day

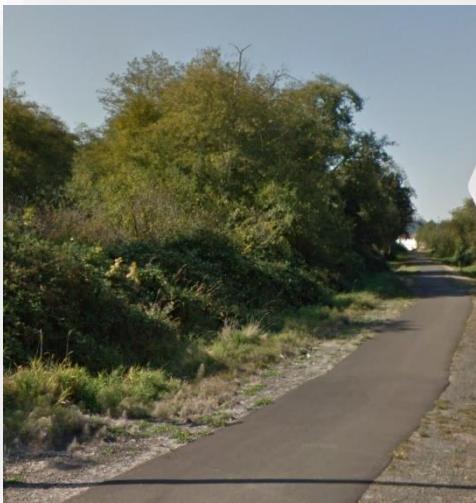
Pioneer Park – Basich Trailway – Good Condition

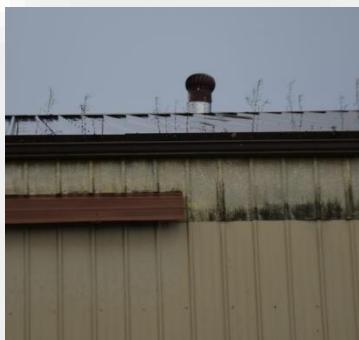
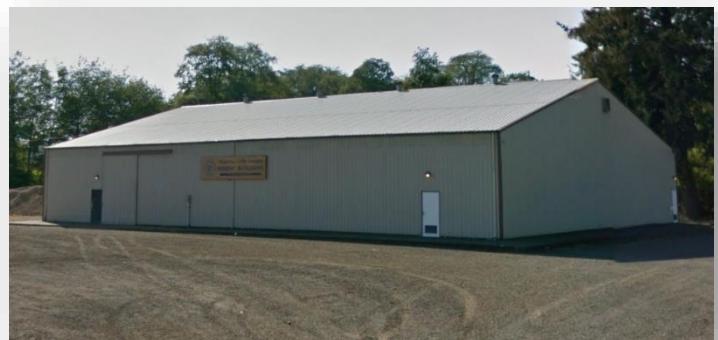
The Batting Cages Building is structurally in good shape, though the roof needs cleaning and buildup of vegetation in the gutters needs cleaning. The gravel lot is in good shape. The adjacent Basich Trailway is paved and accessible, and in great shape with an occasional bench provided. The Parks Department has Parks Maintenance

Pioneer Park – Batting Cage Building, structurally good, but needs some interior and exterior maintenance

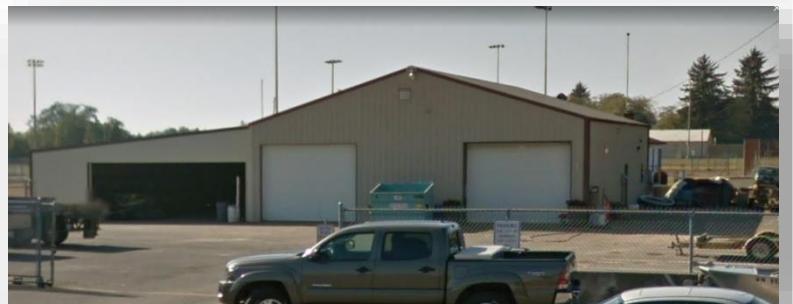
Building located at S. Dewey Street and E Perry Street where they store equipment and supplies. The Building is in relatively good shape though stored materials are building up, and there is a need for additional enclosed space, secured, to protect the Parks equipment. The site is fenced and gated for security purposes.

Pioneer Park – Park Maintenance Facility, secured gate. Serves its purpose, but could benefit from more enclosed space to protect Park equipment

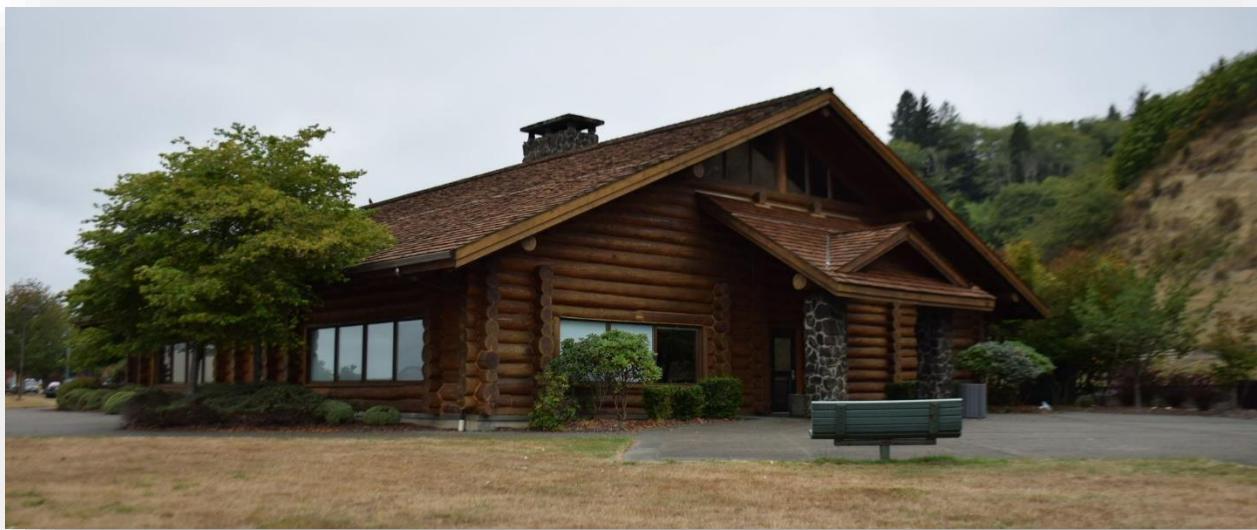
Rotary Log Pavilion at Morrison Park

48	ROOFING	x										
49	EXTERIOR FACADES		x				Exterior is due for cleaning and application of log seal [clear] coat and various chinking repairs.					
50	PLUMBING	x										
51	MECHANICAL	x										
52	ELECTRICAL	x										
53	STRUCTURE	x										
54	DOORS/FRAMES/HARDWARE	x										
55	SPECIALTY SYSTEMS: Commercial Kitchen	x										
56	EVIDENCE OF PESTS	x										
57	OTHER	x										
58	OTHER											
TASK / ITEM												
BUILDING SYSTEMS (BUILDING <u>Bathrooms</u>)												
59	INTERIORS		x				Interior of each restroom should be painted					
60	ROOFING		x									
61	EXTERIOR FACADES		x									
62	PLUMBING		x									
63	MECHANICAL		x				Not applicable					
64	ELECTRICAL		x									
65	STRUCTURE		x									
66	DOORS/FRAMES/HARDWARE		x				Doors and frames are in need of repair and painting					
67	SPECIALTY SYSTEMS		x									
68	EVIDENCE OF PESTS		x				Insects					
69	OTHER		x									
70	OTHER		x

Within the Log Pavilion, we suggest the City consider re-seal (clear coat) and repair chinking of the Log Pavilion. The Log Pavilion is in good shape, and selective improvements are minimal, and should be made with careful consideration of preserving the character of the facility.

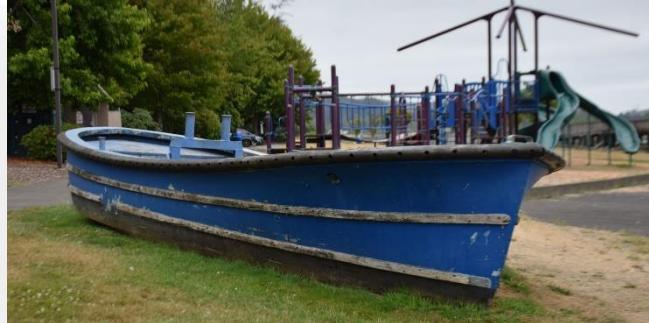
Park amenities like the boat also present numerous safety concerns for anyone who climbs on/in the boat.

Morrison Park – Aging Boat has become a safety hazard

We recommend the City consider adding drinking fountains, including water source for dogs in the dog parks, removal of the boat, and repaving the trail for full ADA accessibility compliance.

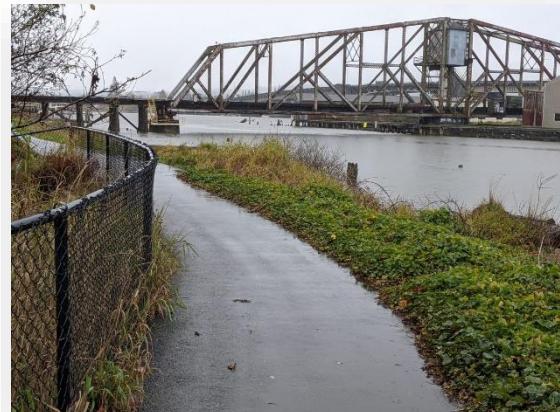
The trail has several safety concerns with walking surfaces and guardrails, but the worst of these conditions is not on property owned by the City.

Morrison Park – Trail Conditions

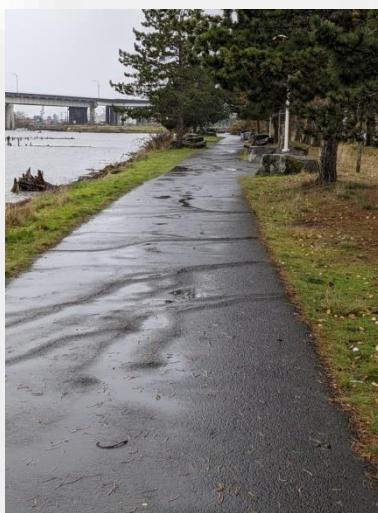
Morrison Park – Trail Conditions

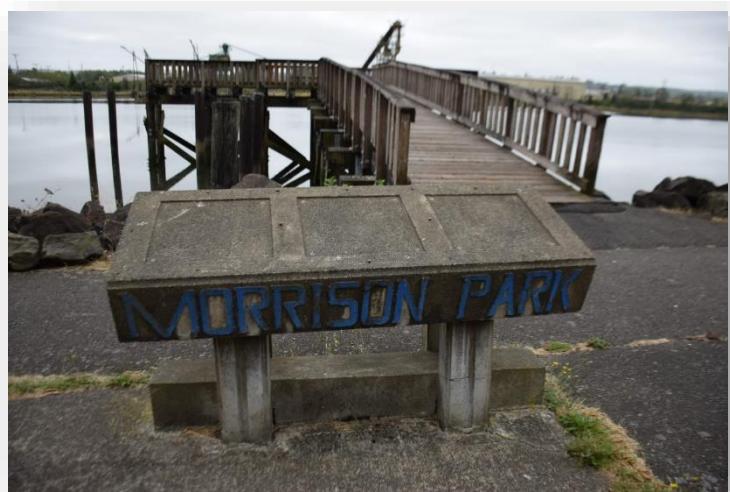
Morrison Park – Sign and Pier

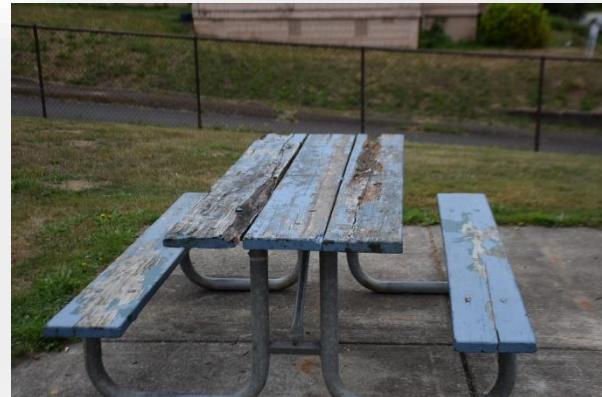
Sam Benn Park – Tables and Benches need replacement

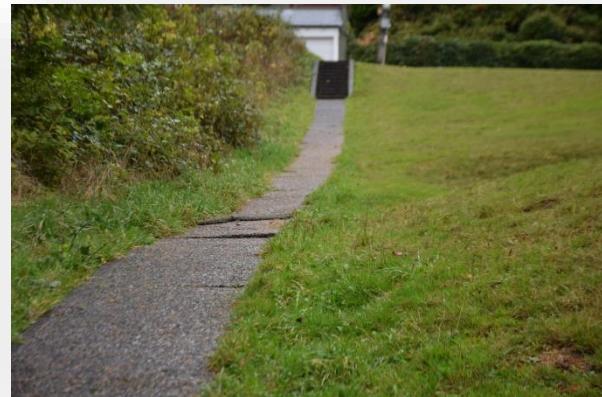
Sam Benn Park – ADA Access recommended

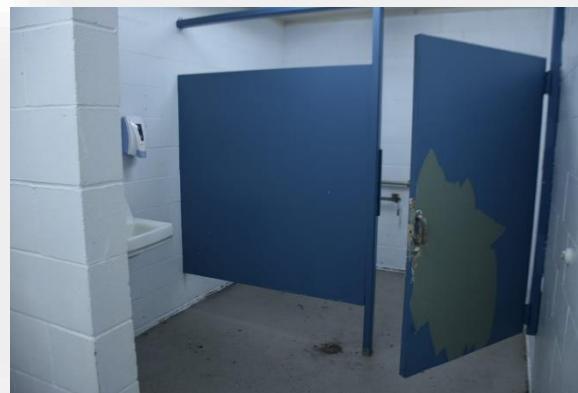
Sam Benn Park – Restrooms in poor shape.

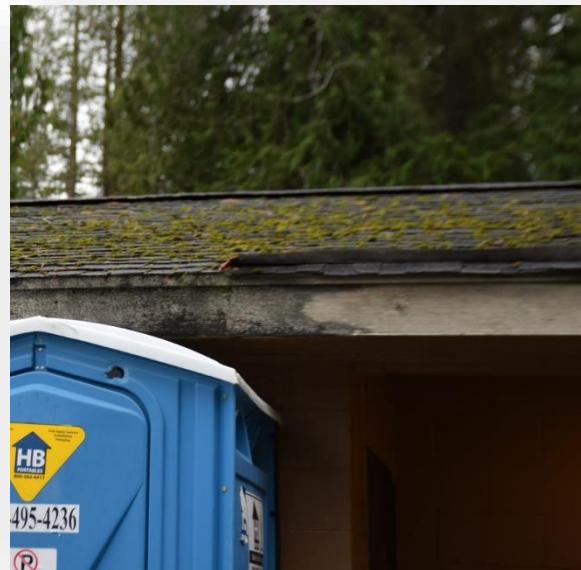
Sam Benn Park – Roofing in bad shape

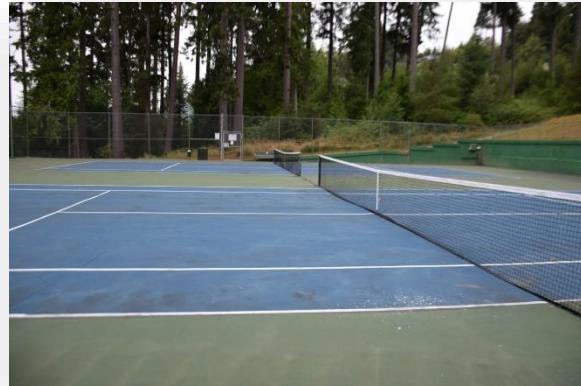
Sam Benn Park – Tennis Courts have ruts in pavement

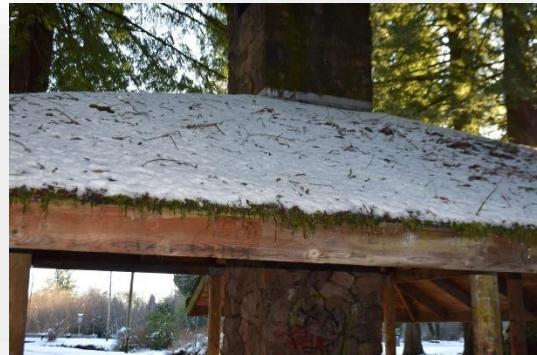
Stewart Park Pavilion Roof

needs new roofing (or at least a thorough cleaning). The concrete slab on grade has experienced significant root heave and needs replacement.

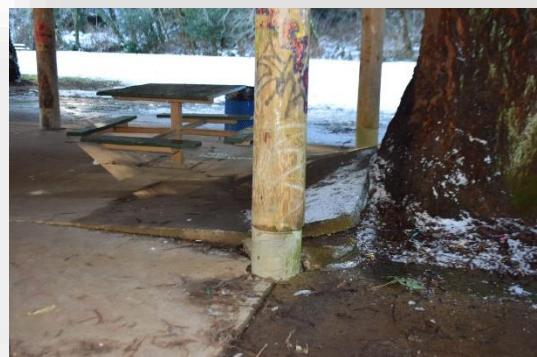
Stewart Park Pavilion Slab Heaving

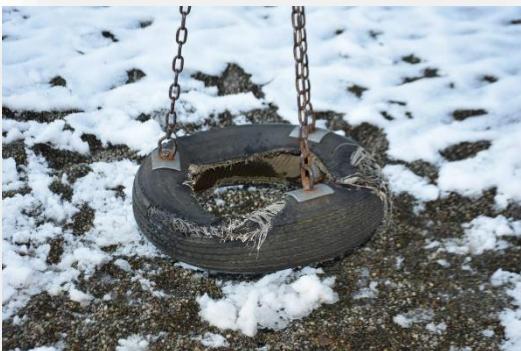
Stewart Park Play Equipment in need of care

The playground equipment is recommended to be replaced within the next 5 years due to the deteriorating condition of the equipment.

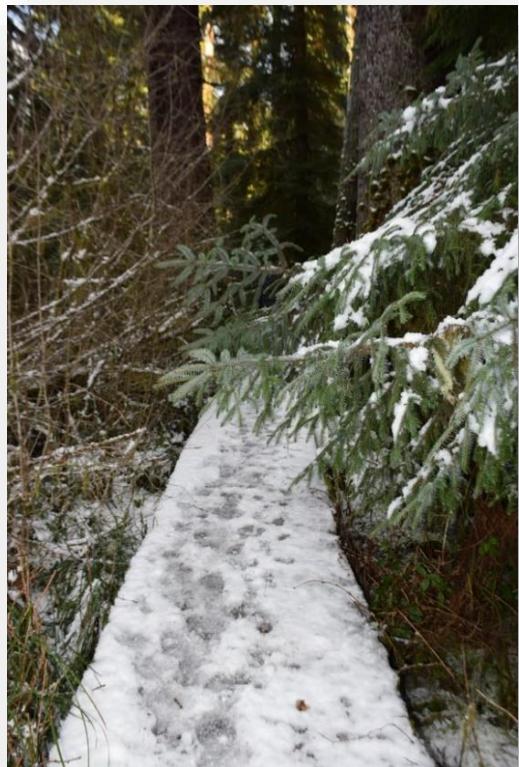
Handrails on raised (deck) pathways are missing, damaged, and in some locations appear to never existed.

Decking boards are slippery and hazardous.

Stewart Park Trail in Poor Condition

RPM recommends the City consider adding drinking fountains, including water source for dogs in the dog parks, and at least some site lighting. The trail has experienced landslides and deterioration of the raised (deck) pathway and needs stabilization before being reopened to the public.

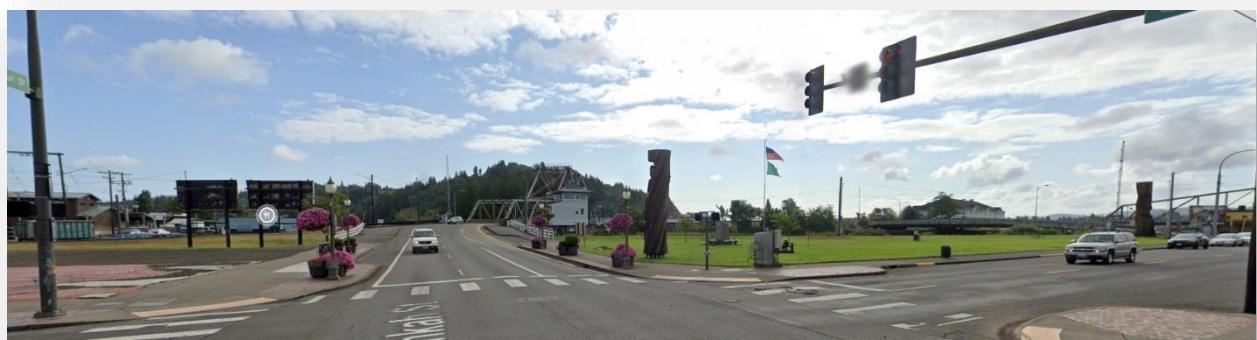
Zelasko Park - Possible Connection to future Gateway Center Project Activities to the North of the Park

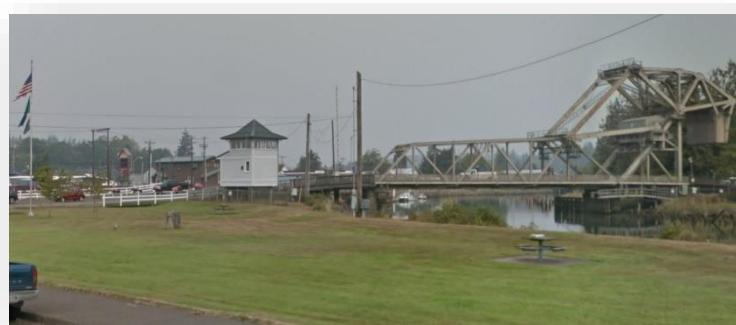
Zelasko Park - View Looking NE from South F-Street

Because the Park can become saturated with water many times of the year, a paved pathway and plaza areas elevated, would be an improvement that would likely result in more use of the Park.

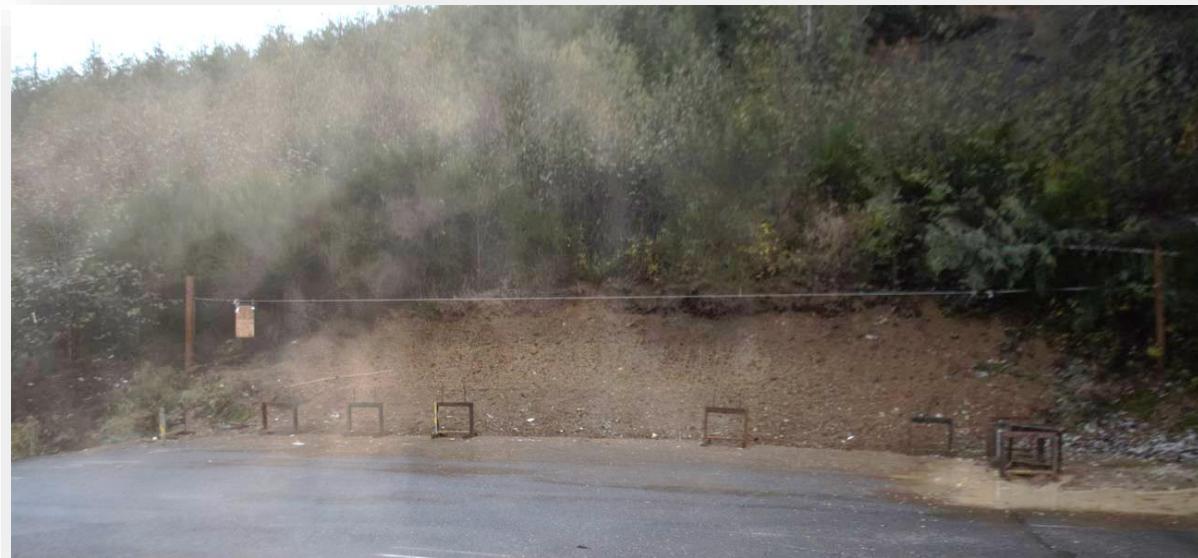
Police – Gun Range Site

The overall condition of the Gun Range is Poor.

Site fencing and vegetation is overgrown. The soils are contaminated. Signage is poor. The decking and back wall are weathered, and rot damage is evident. The main structure appears solid, but stair access is failing and in need of repair.

Recommendations. Construction of a new site for a gun range along Charlie Creek off SR-105 has been evaluated (see separate section of the facilities plan for assessment). RPM recommends that the City consider updating the existing gun range, rather than constructing a new gun range. The existing gun range site has contaminated soil from years of use as a gun range without catch and containment of lead, copper, and steel used for bullets and shot. The City currently owns the existing gun range site, and abandonment or disposal of the property would require addressing the soils contamination.

Renovation of the gun range should begin with construction of a proper backdrop and shooting lanes for 25YD and 100YD targets with proper containment on the site. Soils testing and abatement (removal) of contamination should be completed as the first phase of the project, followed by site improvements, security upgrades, and facilities renovations.

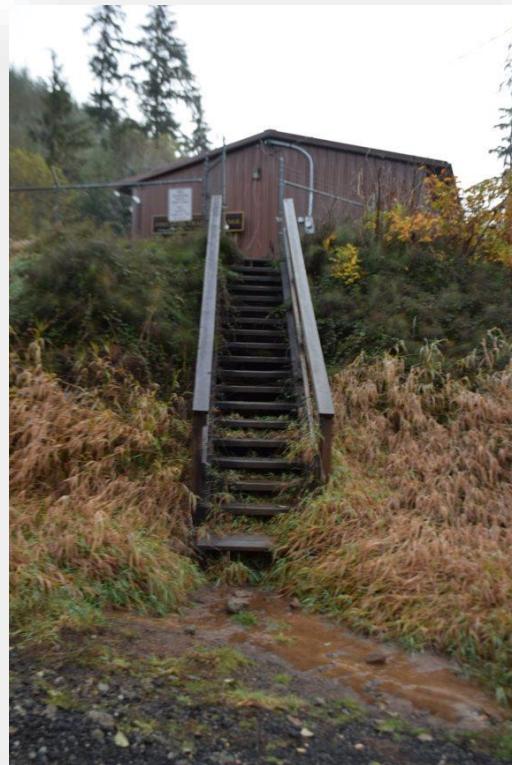
Police – Gun Range Site – Access is unsafe

As an interim effort, RPM recommends the site be better secured, debris be removed, fencing repaired, and planning be started for renovation of the existing gun range.

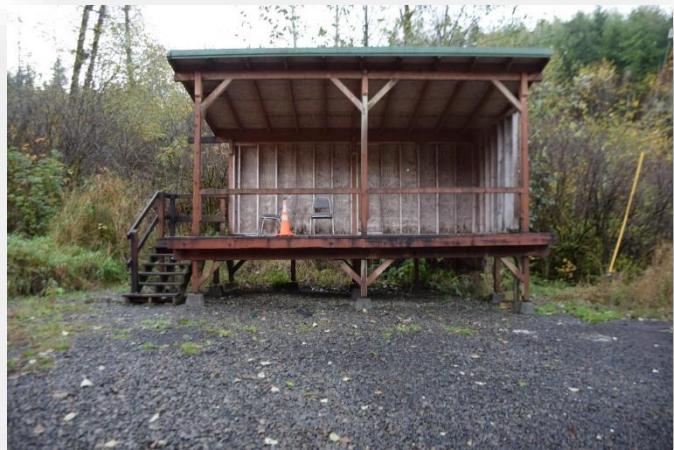
68	EVIDENCE OF PESTS					Not observed, did not have access to interior space	
69	OTHER						
70	OTHER						
	TASK / ITEM						
	BUDING SYSTMES (BUILDING Lean-to)						
71	INTERIORS				X	Decking and back wall are aging, weathered, and rot damage	
72	ROOFING						
73	EXTERIOR FACADES		X	X		Weathered, rot damage	
74	PLUMBING					Not applicable	
75	MECHANICAL					Not applicable	
76	ELECTRICAL					Not applicable

Police – Gun Range Site – "Lean-To" Structure

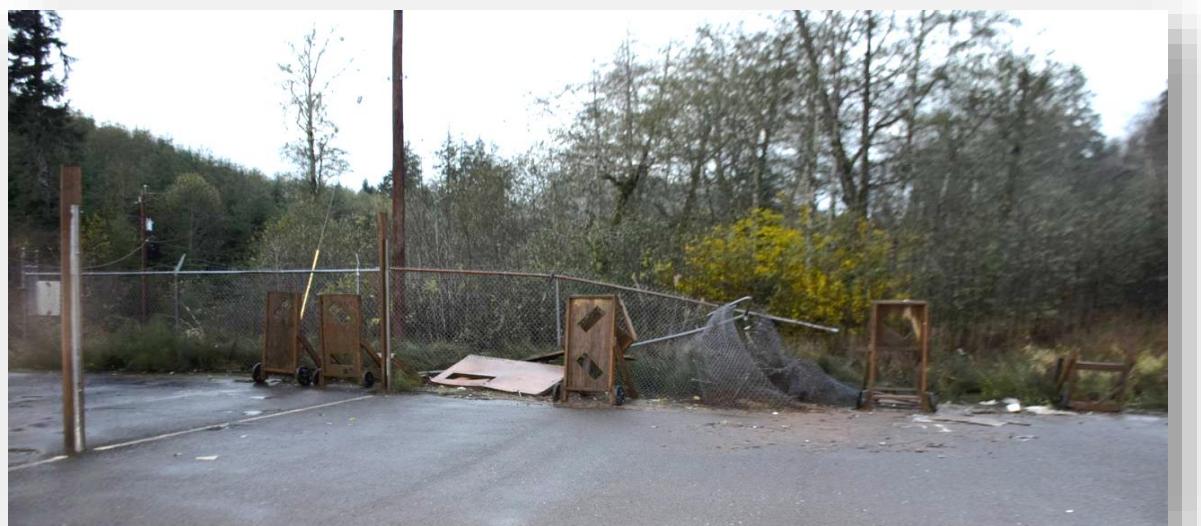
Police – Gun Range Site – Fencing has collapsed, the site has considerable debris, and is not secured.
